FIRE SAFETY FOLLOW UP INSPECTION

Factory Name	Multifabs Ltd		
Address	Kashimpur, Nayapara, Gazipur		
Inspection Date	04/09/2014		
Date Report Received	01-June/14		
Date of 1st Follow-up	28-July/15	Date of 2nd Follow-up	03-February/16
Date of 3rd Follow-up	18-April/16	Date of 4th Follow-up	01-August/16
Date of 5th Follow-up	26-October/16		
Inspected by	Md. Anayet Hossain.

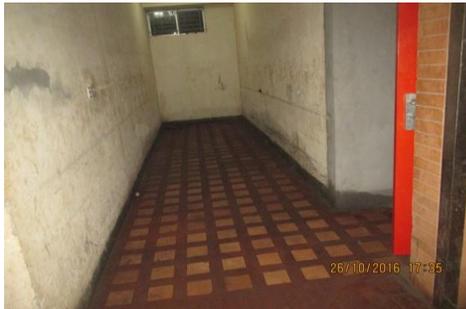
Item No	Accord Observation	Accord Recommendation	Timeline given by Accord	Comments after Physical Inspection	Supposed to complete(D D/MM/YY)	Final Action Plan	Status on the date of Inspection	Pictorial Evidence
1	Diesel fuel storage was located inside the generator room.	Remove all diesel fuel storage from the generator room and relocate to the exterior such that the diesel fuel storage is at least 10 ft. from required egress paths. If located along egress paths or in a utility building, provide the diesel fuel storage with 2-hr fire rated construction. There shall be no diesel fuel storage in a factory Provide dedicated storage rooms separated by minimum	Immediately	On 03/02/16: Corrected. On 18/04/16: Corrected. Removed. On 01/08/2016: Corrected. On 26/10/2016: Corrected.	19/06/2015		Corrected

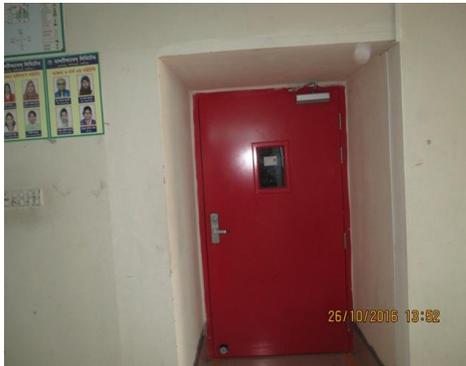
2	Rooms used for combustible storage are not separated by fire-rated construction on basement, ground, first, fourth, fifth, sixth and ninth floors.	1-hr fire-rated construction. Where separate storage rooms are not feasible, provide defined storage areas and limit the storage arrangement as follows: - Maximum height of 2.45m (8ft.) and maximum area of 23m ² (250 ft ²) - If sprinkler protected: maximum height of 3.66m (12ft.) and maximum area of 93m ² (305ft ²) Separate areas of unenclosed combustible storage by a minimum clear	Within 3 months	On 03/02/16: Maximum fire doors have been installed. Others are in the ongoing process. Civil work in progress. On 18/04/16: For the mentioned floors in Accord observation factory has installed fire doors but few doors are not having the vision panel thus creating penetrations. Interfacing with FACP is required as they are keeping their doors open. On 01/08/2016: Corrected. Fire doors are installed & interfaced with Fire Alarm Control panel. On 26/10/2016: Corrected.	30/06/2016		Corrected

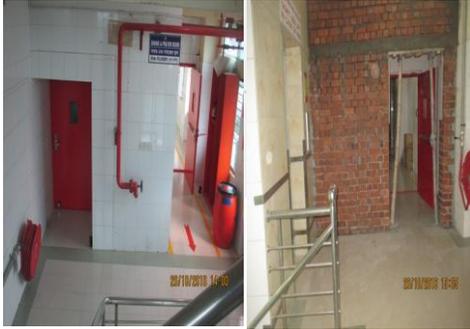
Item No	Accord Observation	Accord Recommendation	Timeline given by Accord	Comments after Physical Inspection	Supposed to complete(D D/MM/YY)	Final Action Plan	Status on the date of Inspection	Pictorial Evidence
3	The exit stairs are not separated from work areas and other spaces on each floor by fire-rated construction.	Provide minimum 1.5-hr fire rated doors for buildings that are 4 or more stories. Seal all unprotected openings to separate the exit stairs from work areas and other building spaces on all floor levels. Ensure that the fire doors are self-closing and positive latching and that they are provided with fire exit (panic) hardware where serving production floors. If fire doors are required to be held open for functional reasons, provide automatic closing devices tied to the fire alarm system. Once fire doors are installed,	Within 3 months	On 03/02/16: Partially corrected. Maximum doors have been installed. Civil work and installation in progress. On 18/04/16: Both staircases are not separated from the ground floor utility section & storage area. Office area is not separated from the staircase. Basement work is in progress. Few doors are not having the vision panel thus creating penetrations. Interfacing with FACP is required as they are keeping their doors open. On 01/08/2016: Fire doors are installed and almost all the doors are interfaced with Fire Alarm Control Panel (FACP). Few doors were found not interfaced with FACP. Moreover, there was an unsealed opening from the Electrical shaft. On roof level , idle machine storage was not separated from exit stair. On 26/10/2016: Partially corrected.	30/06/2016		In Progress

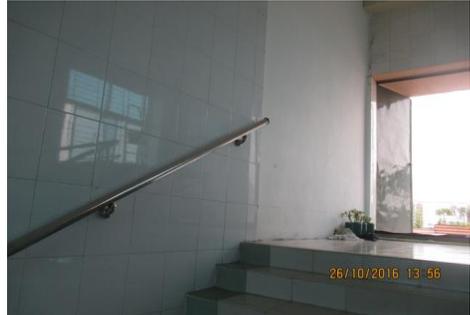
4	The EMR room is not separated by fire-rated construction due to non-rated door and opening in the north exit stair enclosure.	Separate the EMR room by a minimum 2-hr fire rated construction for high rise. Seal and protect all openings to maintain the required fire separations. Provide proper ventilation and consult a qualified engineer.	Within 3 months	On 03/02/16: Not Corrected. The factory committed to solve the situation within committed time. On 18/04/16: Corrected. Exit for the Elevator Machine Room has been modified. On 01/08/2016: Corrected. On 26/10/2016: Corrected.	03/03/2016		Corrected

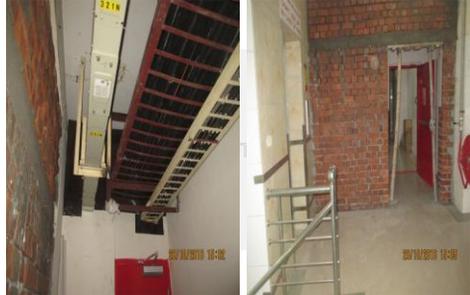
5	Unsealed electrical shafts are located in the fire-rated floor/ceiling assemblies.	Provide a minimum 2-hr fire-rated shaft to separate the utility risers from each floor level and seal all penetrations in floor/ceiling assemblies to maintain the fire separation.	Within 3 months	On 03/02/16: Fire doors are installed in front of the electrical shafts but still few penetration found. On 18/04/16: Vision panel were missing from some of the installed doors. Penetrations were there. On 01/08/2016: Unsealed opening was present at electrical shaft. On 26/10/2016: Work in progress.	30/06/2016		In Progress

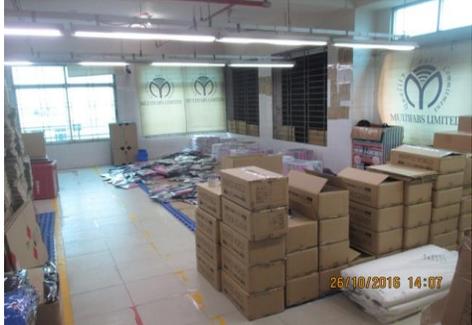
6	Areas used for combustible storage open to the factory are not separated by fire-rated construction on ground, second and third floors.	Provide defined storage areas and limit the storage arrangement as follows: - Maximum height of 2.45m (8ft.) and maximum area of 23m ² (250 ft ²) - If sprinkler protected: maximum height of 3.66m (12ft.) and maximum area of 93m ² (305ft ²) Separate areas of unenclosed combustible storage by a minimum clear distance of 3m (10ft.).	Within 3 months	On 03/02/16: Maximum fire doors have been installed. Others are in the ongoing process. Civil work in progress. On 18/04/16: 4 story building: Interfacing for the fire doors is required. Accessories (vision panel) shall have to be fixed properly. On 01/08/2016: As the sprinkler system installation is not completed yet factory need to maintain defined storage limit (250 sq. ft.) with 10 feet separation between stack. On 26/10/2016: Corrected. Defined storage areas have been maintained.	30/06/2016		Corrected

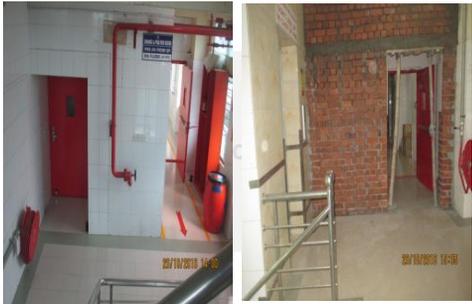
7	The exit stair enclosures are not separated from work areas and other spaces on each floor by fire-rated construction.	The exit stair enclosure shall be provided with a minimum 2-hr fire resistance rating for buildings 4 or more stories.	Within 3 months	On 03/02/16: Maximum fire doors have been installed. Others are in the ongoing process. Civil work in progress. On 18/04/16: 4 story building: Interfacing for the fire doors is required. Accessories (vision panel) shall have to be fixed properly. On 01/08/2016: Fire doors are installed and almost all the doors are interfaced with Fire Alarm Control Panel (FACP). Few doors were found not interfaced with FACP. Moreover, there was an unsealed opening from the Electrical shaft. On roof level, idle machine storage was not separated from exit stair. On 26/10/2016: Partially corrected.	30/06/2016		In Progress

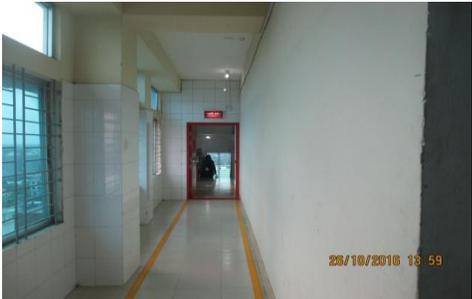
8	Exit access corridors are not provided with 1 hr. fire resistance rating or approved NFPA 13 sprinkler system on the ninth floor.	Provide exit access corridors with 1 hr. fire resistance rating or approved NFPA 13 sprinkler system.	Within 3 months	On 03/02/16: Fire door installation in progress. On 18/04/16: Interfacing for the fire doors is required. Accessories (vision panel) shall have to be fixed properly. On 01/08/2016: Corrected. On 26/10/2016: Corrected.	30/06/2016		Corrected

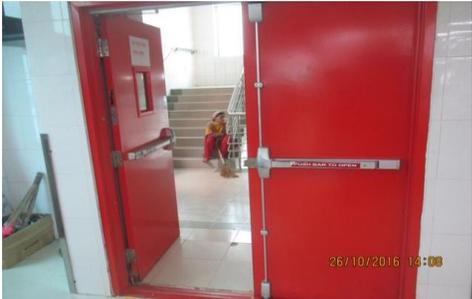
9	Storage rooms discharge directly into all exit stair enclosures.	Openings from exit enclosure to storage spaces shall be provided with a vestibule with fire rated construction and openings. Provide a 1.5 hr. fire rated door on the exit stair side and	Within 3 months	On 03/02/16: Partially corrected. Installation in progress. On 18/04/16: Interfacing for the fire doors is required. Accessories (vision panel) shall have to be fixed properly. On 01/08/2016: Corrected. Store rooms discharges directly into exit stair are provided with fire doors and installed doors are interfaced with Fire Alarm Control Panel. On 26/10/2016: Corrected.	30/06/2016		Corrected

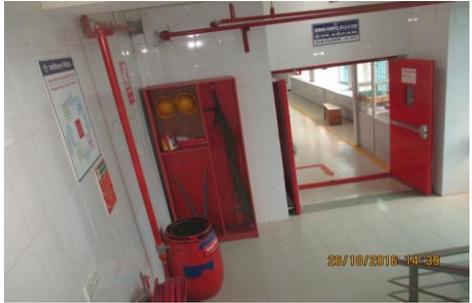
Item No	Accord Observation	Accord Recommendation	Timeline given by Accord	Comments after Physical Inspection	Supposed to complete(D D/MM/YY)	Final Action Plan	Status on the date of Inspection	Pictorial Evidence
10	Unsealed penetrations and openings are located in the south exit stair enclosure.	Seal all penetrations and openings in exit stair enclosure walls to maintain the fire separation.	Within 3 months	On 03/02/16: Penetration still present. Civil work in progress. On 18/04/16: Corrected. Sealed. On 01/08/2016: Corrected. On 26/10/2016: Corrected.	04/03/2016		Corrected

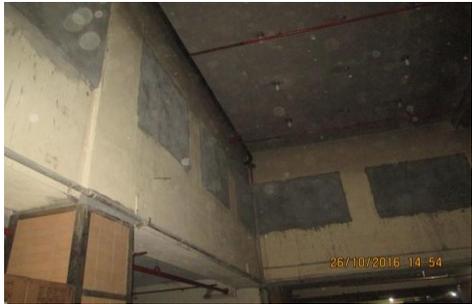
12	Existing atrium in factory connecting ground and first floors is not properly protected.	Provide proper fire protection in accordance with ACCORD standard 3.7.	Within 6 months	On 03/02/16: In progress. On 18/04/16: Corrected. Sealed the openings. On 01/08/2016: Corrected. On 26/10/2016: Corrected.	04/03/2016		Corrected

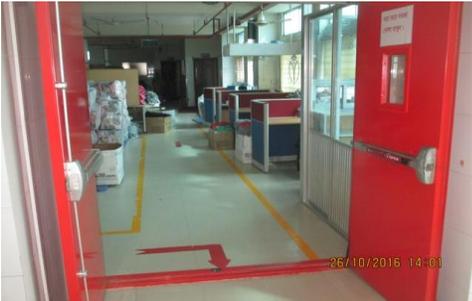
13	Egress doors with locking features are provided at exit stairs. Egress gates with locking features exit stairs and exit	Remove locking features from all egress doors and gates. If locks are required for security reasons, utilize special door locking features complying with NFPA 101 and ACCORD standard 6.8.2.	Immediately	On 03/02/16: Corrected. On 18/04/16: Corrected. Factory has removed the non compliant locking features. On 01/08/2016: Corrected. On 26/10/2016: Corrected.	19/06/2015		Corrected

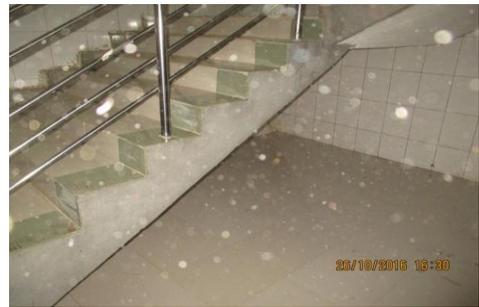
Item No	Accord Observation	Accord Recommendation	Timeline given by Accord	Comments after Physical Inspection	Supposed to complete(D D/MM/YY)	Final Action Plan	Status on the date of Inspection	Pictorial Evidence
14	Storage was located in all exit stairs on the basement.	Remove all storage from exit stairs and egress paths.	Immediately	On 03/02/16: Few storage found. On 18/04/16: Corrected. Removed. On 01/08/2016: Corrected. On 26/10/2016: Corrected.	06/02/2016		Corrected

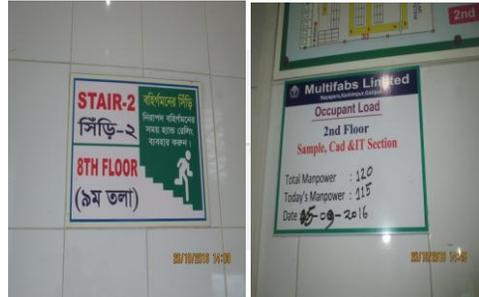
15	Building did not have stair designation signs at exit stairs. Building did not have occupant load signs on the floors.	Provide stair designation signs, occupant load signs and emergency evacuation plans at required locations.	Immediately	On 03/02/16: Not yet corrected. On 18/04/16: Corrected. Stair designation sign & evacuation plans were available during follow-up. After the follow-up factory has immediately printed the occupant load signs on that very day. On 01/08/2016: Corrected. On 26/10/2016: Corrected.	18/04/2016		Corrected

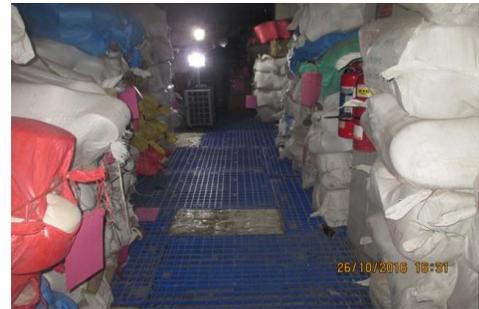
16	Storage was located in the egress paths on the basement. Obstructions were located in the egress paths on the fourth floor.	Keep egress paths and stairs clear of storage and obstruction.	Immediately	On 03/02/16: Corrected. On 18/04/16: Corrected. Cleared the paths. On 01/08/2016: Corrected. On 26/10/2016: Corrected.	19/06/2015		Corrected

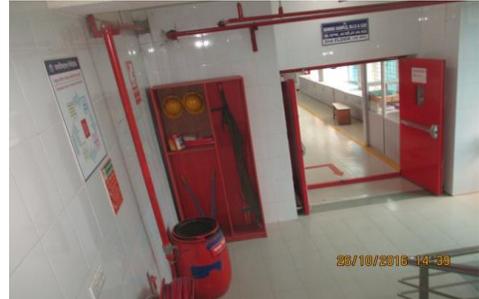
17	Sliding doors are provided at building exit, exit stairs, along egress routes and exit discharges.	Replace all gates and sliding doors along the means of egress with side-hinged, swinging egress doors in accordance with ACCORD standard 6.8.1.	Within 1 month	On 03/02/16: Corrected. On 18/04/16: Corrected. Factory has removed the non complaint gates. On 01/08/2016: Corrected. On 26/10/2016: Corrected.	19/06/2015		Corrected

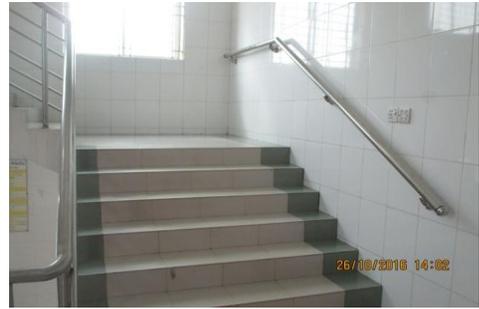
Item No	Accord Observation	Accord Recommendation	Timeline given by Accord	Comments after Physical Inspection	Supposed to complete(D D/MM/YY)	Final Action Plan	Status on the date of Inspection	Pictorial Evidence
18	Handrails are not provided on both sides of all exit stairs.	Provide handrails on both sides of the exit stairs. New handrails shall have a minimum height of 865 mm (34 in.) and a maximum height of 965 mm (38 in.) as measured from the leading edge of the tread. Intermediate handrails shall be provided when the stair width exceeds 2.2 m (87 in.)	Within 3 month	On 03/02/16: Installation in progress. Some stairs are done fully. On 18/04/16: Corrected. Provided. On 01/08/2016: Corrected. On 26/10/2016: Corrected.	03/03/2016		Corrected

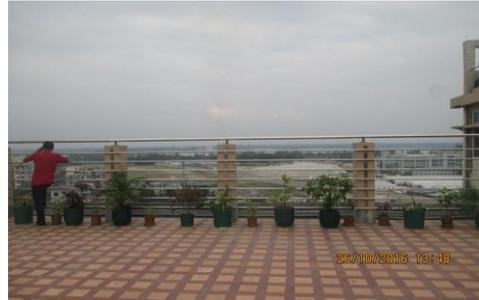
19	The occupiable roof was not provided with an adequate parapet / guard rail.	All occupiable roofs shall be provided with parapets or guards with a minimum height of 1067 mm (42 in.)	Within 3 month	On 03/02/16: Corrected. On 18/04/16: Corrected. Provided. On 01/08/2016: Corrected. On 26/10/2016: Corrected.	19/06/2015		Corrected

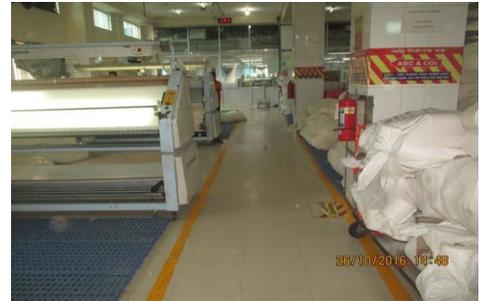
20	The width of egress aisles is less than 36-in. on the eighth floor.	Provide minimum aisle widths of 36-in.	Within 3 month	On 03/02/16: Corrected. On 18/04/16: Corrected. Aisles of adequate width have been found during 3rd follow-up. On 01/08/2016: Corrected. On 26/10/2016: Corrected.	19/06/2015		Corrected

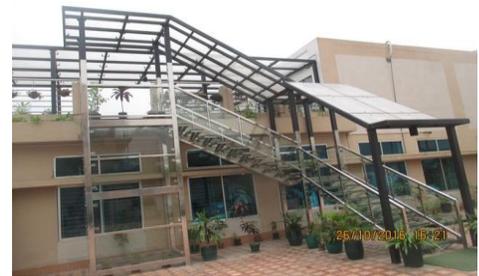
21	A single means of egress is provided from roof top where the occupant load and travel distance is	Provide additional means of egress in accordance with the Accord Standard.	Within 3 month	On 03/02/16: Corrected. The factory added a new stair to the floor. On 18/04/16: Corrected. Provided. On 01/08/2016: Corrected. On 26/10/2016: Corrected.	19/06/2015		Corrected

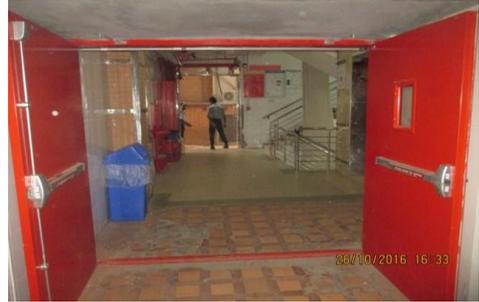
Item No	Accord Observation	Accord Recommendation	Timeline given by Accord	Comments after Physical Inspection	Supposed to complete(D D/MM/YY)	Final Action Plan	Status on the date of Inspection	Pictorial Evidence
22	North exit stair discharges inside the building on the ground floor. The exit discharge is open to parking area.	Provide 2-hr fire-rated exit passageway leading directly outside (vestibules to separate any storage areas).	Within 6 month	On 03/02/16: Not yet corrected. Still a stair discharge to parking area. On 18/04/16: No action has been taken yet. Factory needs to do some civil work here. On 01/08/2016: This issue is applicable for South Exit Stair. Factory has provided alternative path for exit discharge from South Exit. Fire door is installed but fire door was found open manually. On 26/10/2016: It has been found same as it was last (4th) follow-up.	30/06/2016		In Progress

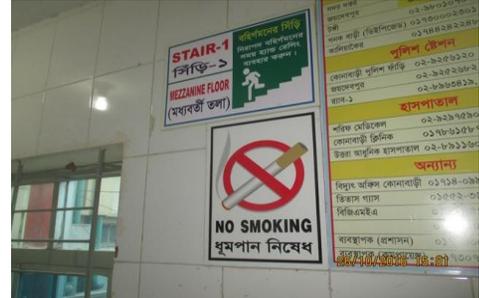
25	The required no smoking signs are not present in the factory.	Smoking is prohibited in any garment factory building or separate storage building. Signs shall be posted in Bengali and English at all building entrances. If the factory creates a designated smoking area outside of these	Within 1 month	On 03/02/16: Corrected. On 18/04/16: Corrected. Provided. On 01/08/2016: Corrected. On 26/10/2016: Corrected.	19/06/2015		Corrected

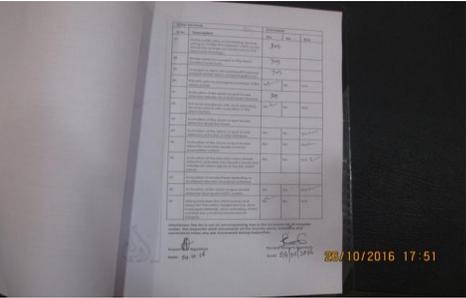
Item No	Accord Observation	Accord Recommendation	Timeline given by Accord	Comments after Physical Inspection	Supposed to complete(D/D/MM/YY)	Final Action Plan	Status on the date of Inspection	Pictorial Evidence
26	Inspection, testing and maintenance for the fire alarm system is not in accordance with NFPA 72.	Inspect, test and maintain the fire alarm system and keep written records on-site, in accordance with NFPA 72.	Within 3 months	On 03/02/16: It is an integrated part of fire alarm system. On 18/04/16: It is an integrated part of fire alarm system. On 01/08/2016: Corrected. On 26/10/2016: Corrected.	30/06/2016		Corrected

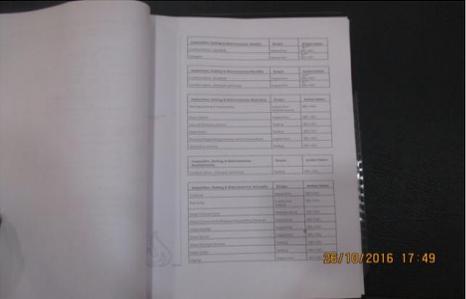
27	Inspection, testing and maintenance of the standpipe system is not in accordance with NFPA 14.	Inspect, test and maintain the standpipe system and keep written records on-site, in accordance with NFPA 14.	Within 3 months	On 03/02/16: It is an integrated part of fire fighting system. On 18/04/16: It is an integrated part of fire fighting system. On 01/08/2016: Corrected. On 26/10/2016: Corrected.	30/06/2016		Corrected

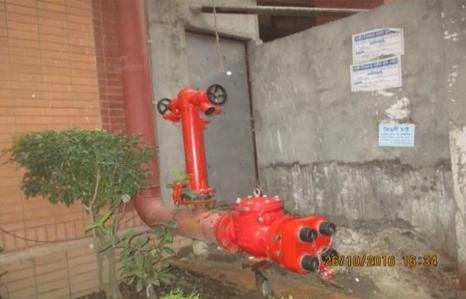
28	Fire department connection is not provided.	Provide fire department connection in accordance with ACCORD standard 5.5.4.	Within 3 months	On 03/02/16: It is an integrated part of fire fighting system. On 18/04/16: It is an integrated part of fire fighting system. On 01/08/2016: It is an integrated part of Fire Fighting system. On 26/10/2016: Corrected.	30/06/2016		Corrected

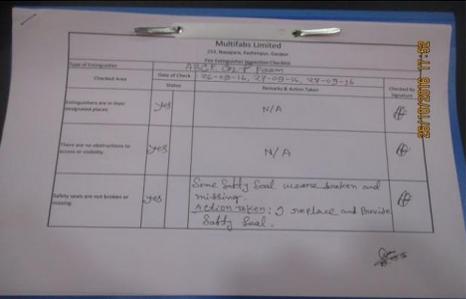
29	Inspection, testing and maintenance of portable fire extinguishers is not in accordance with NEDA 10	Inspect, test and maintain the portable fire extinguishers and keep written records onsite, in accordance with NFPA 10.	Within 3 months	On 03/02/16: Not done according to Accord standard. On 18/04/16: Corrected. Factory is maintaining the checklist as per the standard. On 01/08/2016: Corrected. On 26/10/2016: Corrected.	22/03/2016		Corrected

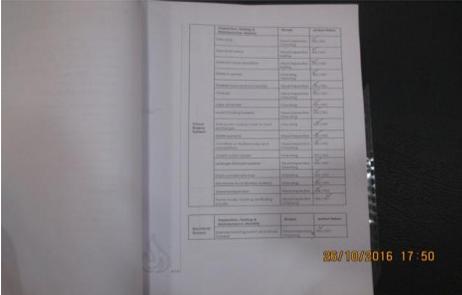
Item No	Accord Observation	Accord Recommendation	Timeline given by Accord	Comments after Physical Inspection	Supposed to complete(D D/MM/YY)	Final Action Plan	Status on the date of Inspection	Pictorial Evidence
30	Inspection, testing and maintenance of the fire pump system is not in accordance with NFPA 20.	Inspect, test and maintain the fire pump system and keep written records on-site, in accordance with NFPA 20.	Within 3 months	On 03/02/16: It is an integrated part of stand pipe system. On 18/04/16: It is an integrated part of fire fighting system system. On 01/08/2016: Corrected. On 26/10/2016: Corrected.	30/06/2016		Corrected

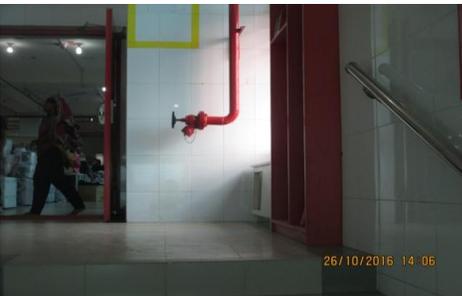
32	The required standpipe system is not installed in accordance with the ACCORD standard.	Install a new standpipe system in accordance with ACCORD standard 5.4 and NFPA 14. A class III system shall be installed in buildings with the highest occupiable floor 10 m (33 ft.) above grade or more. A class I system shall be permitted in buildings protected throughout by an approved automatic sprinkler	Within 6 months	On 03/02/16: Design have been reviewed by Accord. Installation in progress. On 18/04/16: Reviewed design from Accord was available during the follow-up. Piping work was almost completed. All materials were available in the factory premises. Factory committed to complete the installation within the mentioned timeline. On 01/08/2016: Installation is in progress. On 26/10/2016: Installation work is going on.	31/07/2016		In Progress

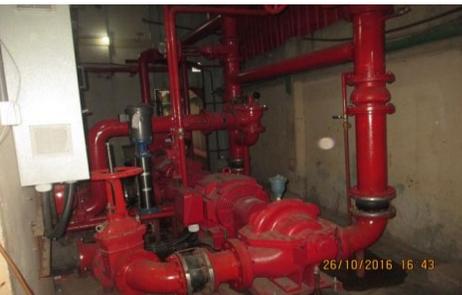
33	Fire pump did not meet ACCORD standard 5.5.1 and 5.5.1.1.	Update current fire pump or provide a new fire pump that meets ACCORD standard 5.5.	Within 6 months	On 03/02/16: Factory will replacer the old pump with new pump. Integrated part of fire hydrant system. On 18/04/16: It is an integrated part of fire fighting system system On 01/08/2016: It is an integrated part of Fire Fighting system. On 26/10/2016: In progress. It is an integrated part of Fire Fighting system.	30/06/2016		In Progress

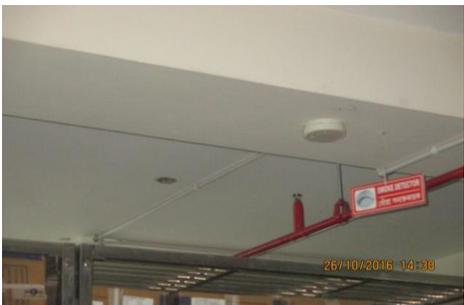
Item No	Accord Observation	Accord Recommendation	Timeline given by Accord	Comments after Physical Inspection	Supposed to complete(D D/MM/YY)	Final Action Plan	Status on the date of Inspection	Pictorial Evidence
34	The building is equipped with single-station smoke alarms. Smoke alarm activation sounds only a local alarm and does not provide automatic fire alarm	Remove single-station smoke alarms. Provide automatic smoke detection throughout the building, tied into the fire alarm system, in accordance with NFPA 72.	Within 9 months	On 03/02/16: Design has been reviewed by Accord. Work in progress. On 18/04/16: It is an integrated part of fire alarm system. On 01/08/2016: Single station smoke alarms are removed with smoke detectors but installed smoke detectors were not functional. On 26/10/2016: It is an integrated part of fire alarm system.	30/06/2016		In Progress

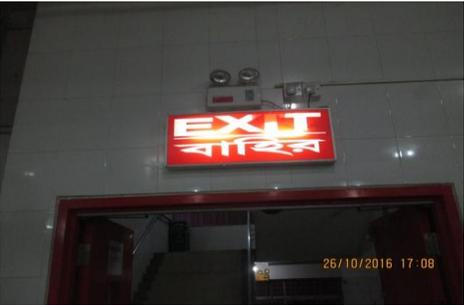
35	Exit signage was not provided at building exits.	Provide exit signs above all building exits to the exterior, all doors to the exit stairs and along all paths of travel where a change of direction is not obvious.	Within 1 month	On 03/02/16: Corrected. On 18/04/16: During 3rd follow-up, it was observed that, directional exit signs were not adequate along all paths of travel where a change of direction is not obvious. On 01/08/2016: Corrected. On 26/10/2016: Corrected.	18/05/2016		Corrected

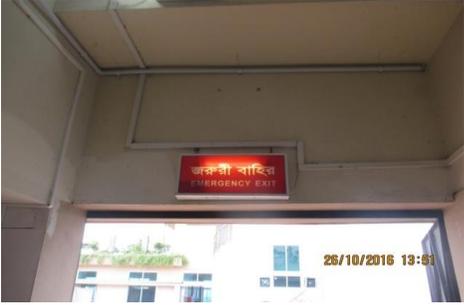
36	Exit signage not illuminated on the third floor.	Regularly inspect all exit signage and replace/install lights as needed to illuminate signs. The source of illumination shall provide not less than 50 lux at the illuminated surface with a contrast of not less than 0.5. Approved self luminous signs which provide evenly illuminated letters having a minimum luminance of 0.2	Within 1 month	On 03/02/16: Corrected. On 18/04/16: Corrected. Exit signs have been illuminated. On 01/08/2016: Corrected. On 26/10/2016: Corrected.	19/06/2015		Corrected

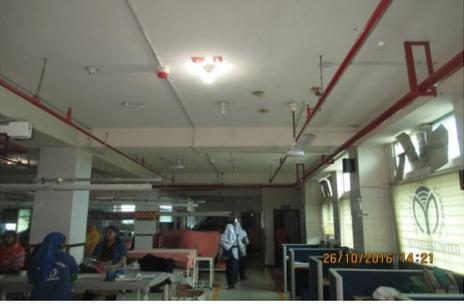
37	Based on the number and location of emergency lights observed, adequate illumination levels are not anticipated	Test the emergency lighting system on each floor and provide additional emergency fixtures to supply adequate illumination along the means of egress. Provide a minimum illumination of 10 lux at the floor level within exit stairs and along exit	Within 3 months	On 03/02/16: Adequate light are not found in the factory floors. On 18/04/16: Corrected. During the follow-up, adequate illumination has been observed along the egress routes. On 01/08/2016: Corrected. On 26/10/2016: Corrected.	18/02/2016		Corrected

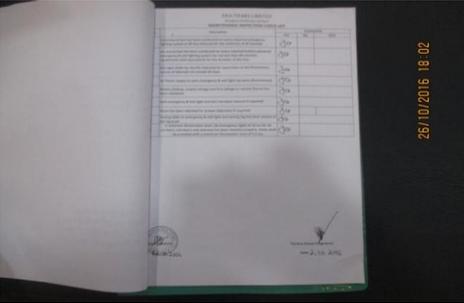
Item No	Accord Observation	Accord Recommendation	Timeline given by Accord	Comments after Physical Inspection	Supposed to complete(D D/MM/YY)	Final Action Plan	Status on the date of Inspection	Pictorial Evidence
38	Inspection, testing and maintenance for the emergency lighting system was not in accordance with The ACCORD standard.	Inspect, test and maintain the emergency lighting system in the accordance with The ACCORD standard. Keep written records on-site.	Within 3 months	On 03/02/16: Not according to the Accord standard. On 18/04/16: Corrected. Factory is maintaining the checklist as per the standard. On 01/08/2016: Corrected. On 26/10/2016: Corrected.	10/02/2016		Corrected

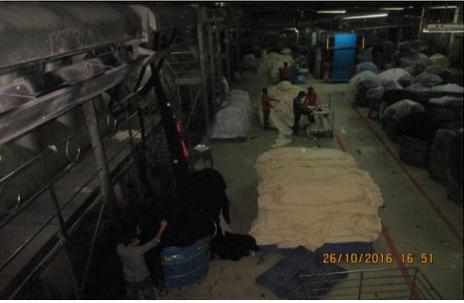
39	Areas used for combustible storage open to the factory are not separated by fire-rated construction on the factory floor.	Provide defined storage areas and limit the storage arrangement as follows: - Maximum height of 2.45m (8ft.) and maximum area of 23m ² (250 ft ²) - If sprinkler protected: maximum height of 3.66m (12ft.) and maximum area of 93m ² (305ft ²) Separate areas of unenclosed combustible storage by a minimum clear distance of 3m (10ft) Separate the boiler room by a	Within 3 months	On 03/02/16: Corrected. On 18/04/16: Corrected. During the follow-up, no such storage has been found. On 01/08/2016: Corrected. On 26/10/2016: Corrected.	07/08/2015		Corrected

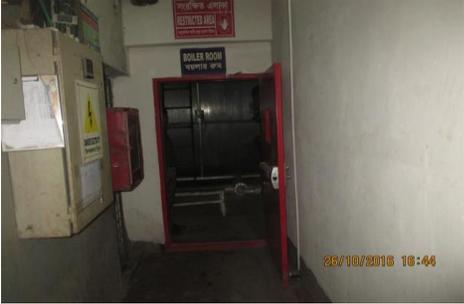
40	The boiler room is not separated by fire-rated construction due to openings and penetrations from the dyeing shed.	minimum 2-hr fire-rated construction for high rise building. Seal and protect all openings to maintain the required fire separations. When located to the exterior of a building, 3m (10 ft.) separation is required. Provide proper ventilation and consult a qualified engineer.	Within 3 months	On 03/02/16: Fire doors installed but penetration still found. On 18/04/16: Partially corrected. Interfacing for fire door with FACP is pending & penetrations have been found. On 01/08/2016: Separation work was going on. On 26/10/2016: Corrected.	15/07/2016		Corrected

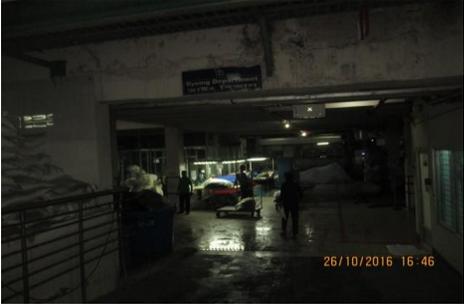
41	Egress doors with locking features are provided at building exits.	Remove locking features from all egress doors and gates. If locks are required for security reasons, utilize special door locking features complying with NFPA 101 and ACCORD standard 6.8.2.	Immediately	On 03/02/16: Corrected. On 18/04/16: Corrected. Factory has removed non-compliant locking features. On 01/08/2016: Corrected. On 26/10/2016: Corrected.	01/08/2014		Corrected

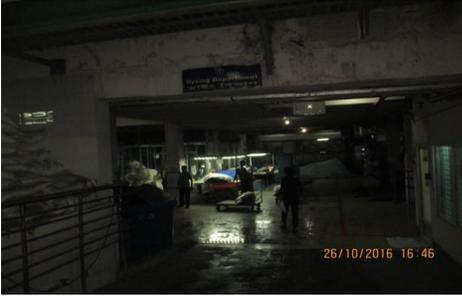
Item No	Accord Observation	Accord Recommendation	Timeline given by Accord	Comments after Physical Inspection	Supposed to complete(D D/MM/YY	Final Action Plan	Status on the date of Inspection	Pictorial Evidence
42	Collapsible gates are provided at building exits.	Replace all gates along the means of egress with sidehinged, swinging egress doors in accordance with ACCORD standard 6.8.1.	Within 1 month	On 03/02/16: Corrected. On 18/04/16: Corrected. Factory has removed non-compliant gates. On 01/08/2016: Corrected. On 26/10/2016: Corrected.	03/02/2016		Corrected

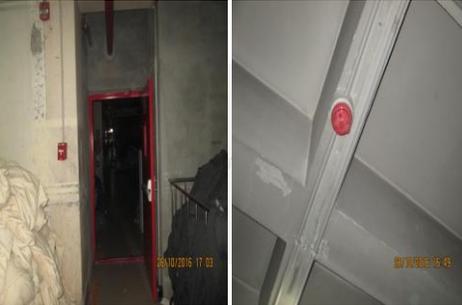
43	The fire alarm system is antiquated, not a listed system and does not provide alarm and notification features consistent with acceptable standards.	Replace the fire alarm system with a new, listed addressable fire alarm system in accordance with NFPA 72.	Design within 4 months, install within 9 months	On 03/02/16: Design reviewed by Accord and installation in progress. On 18/04/16: Reviewed design from Accord was available during the follow-up. All devices were available in the factory premises. In the as-built drawing, factory needs to bring some change for the dyeing shed. Factory committed to complete the installation within the mentioned timeline. On 01/08/2016: Work in progress. On 26/10/2016: In progress.	30/06/2016		In Progress

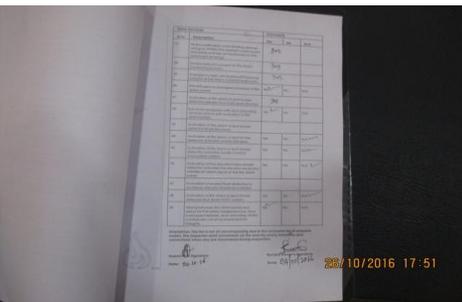
45	Inspection, testing and maintenance for the fire alarm system is not in accordance with NFPA 72.	Inspect, test and maintain the fire alarm system and keep written records on-site, in accordance with NFPA 72.	Within 3 months	On 03/02/16: It is an integrated part of fire alarm system. On 18/04/16: It is an integrated part of fire alarm system. On 01/08/2016: Maintaing ITM for existing system. On 26/10/2016: Corrected.	30/06/2016		Corrected

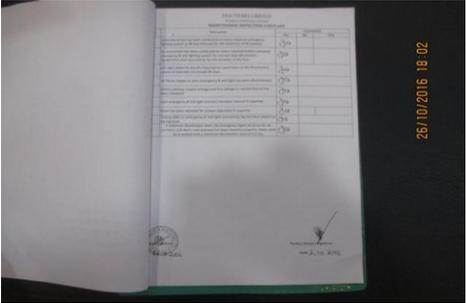
Item No	Accord Observation	Accord Recommendation	Timeline given by Accord	Comments after Physical Inspection	Supposed to complete(D/D/MM/YY)	Final Action Plan	Status on the date of Inspection	Pictorial Evidence
50	Inspection, testing and maintenance for the emergency lighting system was not in accordance with The ACCORD standard.	Inspect, test and maintain the emergency lighting system in the accordance with The ACCORD standard. Keep written records on-site.	Within 3 months	On 03/02/16: Not according to the Accord standard. On 18/04/16: Corrected. Factory is maintaining the checklist as per the standard. On 01/08/2016: Corrected. On 26/10/2016: Corrected.	10/02/2016		Corrected

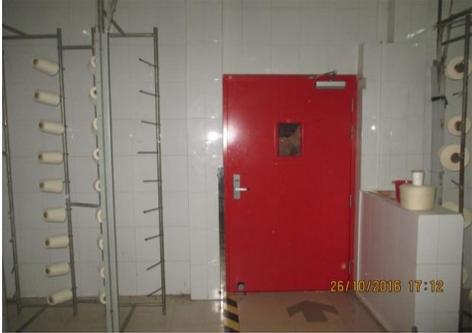
51	Rooms used for combustible storage are not separated by fire-rated construction on the sixth floor and fifth floor.	Provide dedicated storage rooms separated by minimum 1-hr fire-rated construction. Where separate storage rooms are not feasible, provide defined storage areas and limit the storage arrangement as follows: - Maximum height of 2.45m (8ft.) and maximum area of 23m2 (250 ft2) - If sprinkler protected: maximum height of 3.66m (12ft.) and maximum area of 93m2 (305ft2) Separate areas of unenclosed combustible storage by a minimum clear Provide minimum 1.5-hr fire rated doors for buildings that are 4 or more stories. Seal all unprotected openings to separate the exit stairs from work areas and other building spaces on all floor levels. Ensure that the fire doors are self-closing and positive latching and that they are provided with fire exit (panic) hardware where serving production floors. If fire doors are required to be held open for functional reasons, provide	Within 3 months	On 03/02/16: Partially Corrected. Civil work along with installation in progress. On 18/04/16: Factory has installed fire doors but few doors are not having the vision panel thus creating penetrations. Interfacing with FACP is required as they are keeping their doors open. On 01/08/2016: Corrected. On 26/10/2016: Corrected.	30/06/2016		Corrected

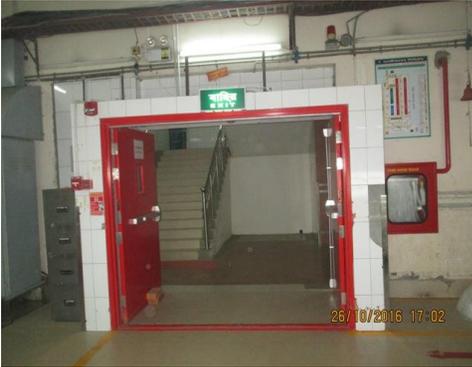
52	The exit stairs are not separated from work areas and other spaces on each floor by fire-rated construction.	Separate areas of unenclosed combustible storage by a minimum clear Provide minimum 1.5-hr fire rated doors for buildings that are 4 or more stories. Seal all unprotected openings to separate the exit stairs from work areas and other building spaces on all floor levels. Ensure that the fire doors are self-closing and positive latching and that they are provided with fire exit (panic) hardware where serving production floors. If fire doors are required to be held open for functional reasons, provide	Within 3 months	On 03/02/16: Partially Corrected. Civil work along with installation in progress. On 18/04/16: Few doors are not having the vision panel thus creating penetrations. Interfacing with FACP is required as they are keeping their doors open. In the ground floor, the stairs discharge area is not safe. Civil works are pending for sealing the penetrations (cooling pad, windows). Factory is making a road which will help safe direct discharge for the stairs. On 01/08/2016: Exit stair is not separated from Fire Pump room due to Non-rated Ceiling of Fire pump room. Also unsealed opening is present from production area. On 26/10/2016: Partially Corrected.	30/06/2016		In Progress

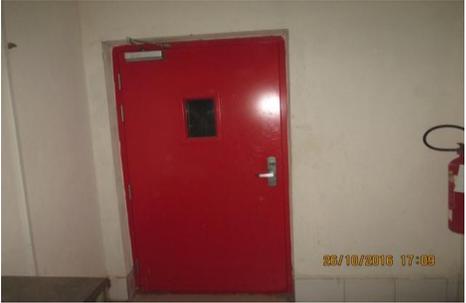
Item No	Accord Observation	Accord Recommendation	Timeline given by Accord	Comments after Physical Inspection	Supposed to complete(D D/MM/YY)	Final Action Plan	Status on the date of Inspection	Pictorial Evidence
53	Unsealed electrical shafts are located in the fire-rated floor/ceiling assemblies.	Provide a minimum 2-hr fire-rated shaft to separate the utility risers from each floor level and seal all penetrations in floor/ceiling assemblies to maintain the fire separation.	Within 3 months	On 03/02/16: Corrected. On 18/04/16: Corrected. Factory has created a fire rated shaft. On 01/08/2016: Corrected. On 26/10/2016: Corrected.	07/08/2015		Corrected

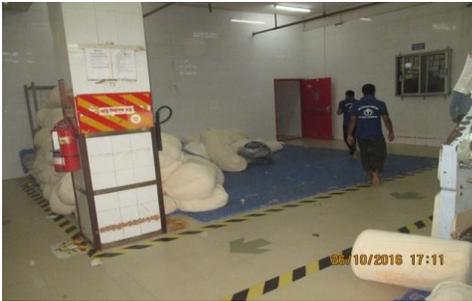
55	Areas used for combustible storage open to the factory are not separated by fire-rated construction on multiple floors.	Provide defined storage areas and limit the storage arrangement as follows: - Maximum height of 2.45m (8ft.) and maximum area of 23m ² (250 ft ²) - If sprinkler protected: maximum height of 3.66m (12ft.) and maximum area of 93m ² (305ft ²) Separate areas of unenclosed combustible storage by a minimum clear distance of 3m (10ft)	Within 3 months	On 03/02/16: Partially corrected. Some doors are still to be installed. On 18/04/16: Factory has installed fire doors but few doors are not having the vision panel thus creating penetrations. Interfacing with FACP is required as they are keeping their doors open. On 01/08/2016: Corrected. As the sprinkler system is installed for the building , area coverage for combustible material is now 1000 sq. ft. On 26/10/2016: Corrected.	30/06/2016		Corrected

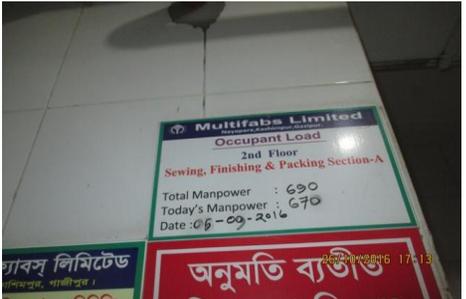
56	Exit capacity (493) is not adequate for the occupant load (650, 710 and 830 respectively) on second, third and fourth	Reduce occupant load immediately to not more than available exit capacity (493). Provide additional exits in the future to increase exit capacity.	Immediately	On 03/02/16: Corrected. On 18/04/16: Partially corrected. Factory has installed another stair but calculating the total width of the stairs the occupant capacity becomes 568 maximum. But during follow-up 780 occupants have been found in the sewing floor. Till the sprinkler installation is not completed, factory needs to reduce the occupant immediately to maximum 568. On 01/08/2016: Not corrected yet. On 26/10/2016: Corrected.	30/07/2016		Corrected

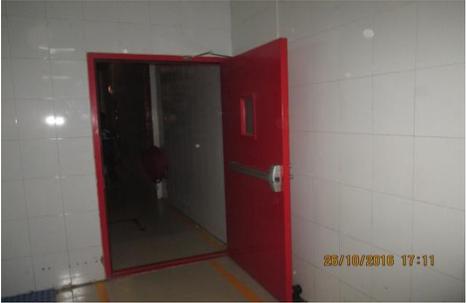
Item No	Accord Observation	Accord Recommendation	Timeline given by Accord	Comments after Physical Inspection	Supposed to complete(D D/MM/YY)	Final Action Plan	Status on the date of Inspection	Pictorial Evidence
57	Egress doors and gates with locking features are provided at exit stairs.	Remove locking features from all egress doors and gates. If locks are required for security reasons, utilize special door locking features complying with NFPA 101 and ACCORD standard 6.8.2.	Immediately	On 03/02/16: Corrected. On 18/04/16: Corrected. Factory has removed non-compliant locking features. On 01/08/2016: Corrected. On 26/10/2016: Corrected.	07/08/2015		Corrected

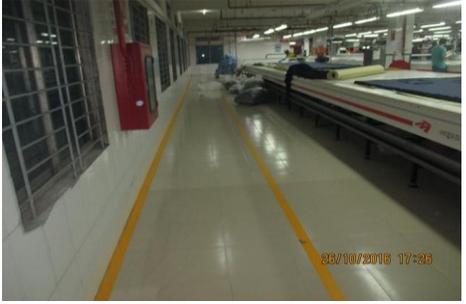
58	Storage was located in the north exit stair on the ground floor.	Remove all storage from exit stairs and egress paths.	Immediately	On 03/02/16: Corrected. On 18/04/16: Corrected. Removed. On 01/08/2016: Corrected. On 26/10/2016: Corrected.	07/08/2015		Corrected

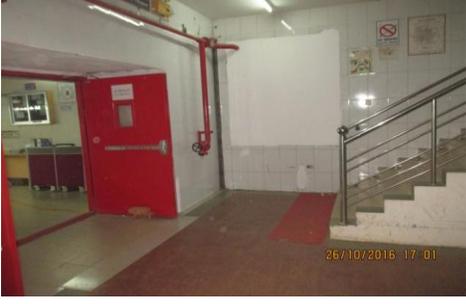
59	Collapsible gates and sliding doors are provided throughout the building.	Replace all gates and sliding doors along the means of egress with side-hinged, swinging egress doors in accordance with ACCORD standard 6.8.1.	Within 1 month	On 03/02/16: The factory have collapsible gate at ground floor. On 18/04/16: Corrected. Removed the non-compliant gates. On 01/08/2016: Corrected. On 26/10/2016: Corrected.	06/02/2016		Corrected

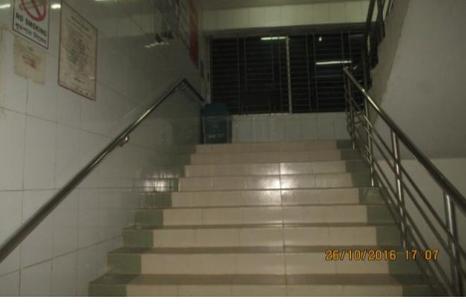
60	Handrails are not provided on both sides of the exit stairs.	Provide handrails on both sides of the exit stairs. New handrails shall have a minimum height of 865 mm (34 in.) and a maximum height of 965 mm (38 in.) as measured from the leading edge of the tread. Intermediate handrails shall be provided when the stair (87 in.)	Within 3 months	On 03/02/16: Corrected. On 18/04/16: Corrected. Provided. On 01/08/2016: Corrected. On 26/10/2016: Corrected.	07/08/2015		Corrected

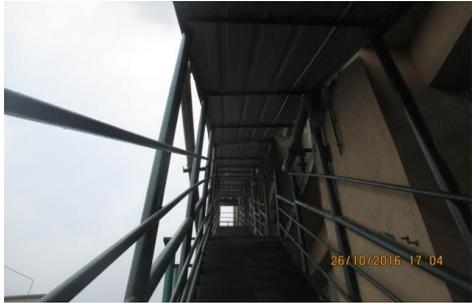
Item No	Accord Observation	Accord Recommendation	Timeline given by Accord	Comments after Physical Inspection	Supposed to complete(D D/MM/YY)	Final Action Plan	Status on the date of Inspection	Pictorial Evidence
61	The number of required exits is not present in factory on second, third and fourth floors.	The number of means of egress from any floor or story shall not be at less than 2 unless it meets ACCORD standard 6.6.2. When load exceeds 500 occupants the number of means of egress shall be at least 3. When load exceeds 1000 occupants the number of means of egress shall be at least 4.	Within 6 months	On 03/02/16: Corrected. On 18/04/16: Corrected. Factory has provided another exit stair. (Solving this issue factory has created another issues like inside discharge, unprotected opening which have been covered by other findings.) On 01/08/2016: Corrected. On 26/10/2016: Corrected.	07/08/2015		Corrected

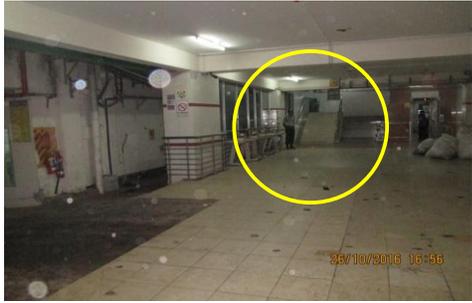
62	East exit stair discharges inside the building on the ground floor.	Provide 2-hr fire-rated exit passageway leading directly outside (vestibules to separate any storage areas).	Within 6 months	On 03/02/16: Not yet corrected. On 18/04/16: A road construction is in progress which will help these stairs providing discharge directly outside. Some civil work is required to seal some windows for the front stair. On 01/08/2016: It was found same as before. On 26/10/2016: Work in progress.	20/05/2016		In Progress

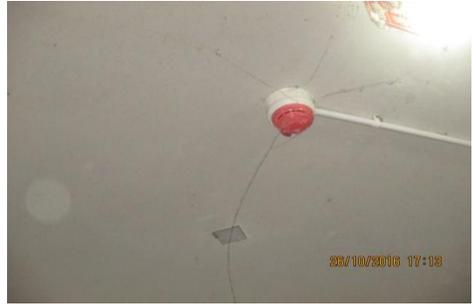
63	The fire alarm system is antiquated, not a listed system and does not provide alarm and notification features consistent with acceptable standards.	Replace the fire alarm system with a new, listed addressable fire alarm system in accordance with NFPA 72.	Design within 4 months, install within 9 months	On 03/02/16: Design reviewed by Accord and installation in progress. On 18/04/16: Reviewed design from Accord was available during the follow-up. Wiring work was almost completed. All devices were available in the factory premises. Factory committed to complete the installation within the mentioned timeline. On 01/08/2016: Installation is complete. Installed system was not functional during inspection. Factory is required to keep As-built Drawing of Fire Alarm & Detection system during Testing & Commissioning. On 26/10/2016: In progress. Installation is completed. Testing and commissioning is pending.	30/06/2016		In Progress

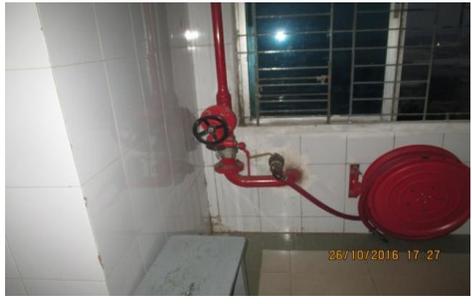
64	The high-rise building has an occupied floor greater than 23m (75 ft.) and is not provided with automatic sprinkler protection. The	Provide automatic sprinkler protection throughout the building in accordance with NFPA 13.	Design within 6 months, install within 12 months	On 03/02/16: Design reviewed by Accord and installation in progress. On 18/04/16: Reviewed design from Accord was available during the follow-up. Piping work was almost completed. All materials were available in the factory premises. Factory committed to complete the installation within the mentioned timeline. On 01/08/2016: Installation is completed. After Testing & Commissioning of Sprinkler system, this issue will be corrected. On 26/10/2016: In progress. Installation is completed. Testing and commissioning is pending.	31/07/2016		In Progress

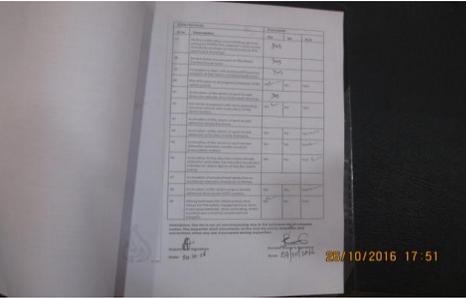
Item No	Accord Observation	Accord Recommendation	Timeline given by Accord	Comments after Physical Inspection	Supposed to complete(D D/MM/YY)	Final Action Plan	Status on the date of Inspection	Pictorial Evidence
65	Inspection, testing and maintenance for the fire alarm system is not in accordance with NFPA 72.	Inspect, test and maintain the fire alarm system and keep written records on-site, in accordance with NFPA 72.	Within 3 months	On 03/02/16: It is an integrated part of fire alarm system. Design reviewed by Accord and installation in progress. On 18/04/16: It is an integrated part of fire alarm system. On 01/08/2016: Corrected. On 26/10/2016: Corrected.	30/06/2016		Corrected

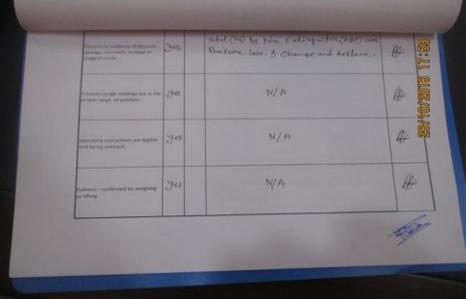
68	Inspection, testing and maintenance of portable fire extinguishers is not in accordance with NEDA 10.	Inspect, test and maintain the portable fire extinguishers and keep written records onsite, in accordance with NFPA 10.	Within 3 months	On 03/02/16: Not yet corrected. On 18/04/16: Corrected. Factory is maintaining the checklist as per the standard. On 01/08/2016: Corrected. On 26/10/2016: Corrected.	10/02/2016		Corrected

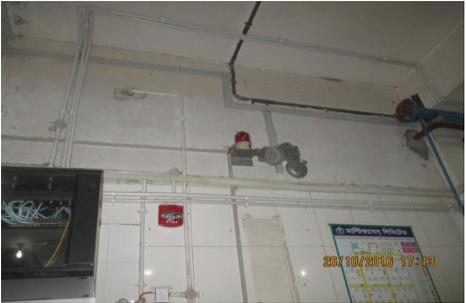
Item No	Accord Observation	Accord Recommendation	Timeline given by Accord	Comments after Physical Inspection	Supposed to complete(D D/MM/YY)	Final Action Plan	Status on the date of Inspection	Pictorial Evidence
69	Visible notification was not provided for the building in accordance with NFPA 72.	Provide visible and audible notification for the building in accordance with NFPA 72.	Within 3 months	<p>On 03/02/16: It is an integrated part of fire alarm system.</p> <p>On 18/04/16: It is an integrated part of fire alarm system.</p> <p>On 01/08/2016: It is an integrated part of Fire Alarm & Detection system.</p> <p>On 26/10/2016: It is an integrated part of fire alarm system.</p>	30/06/2016		In Progress

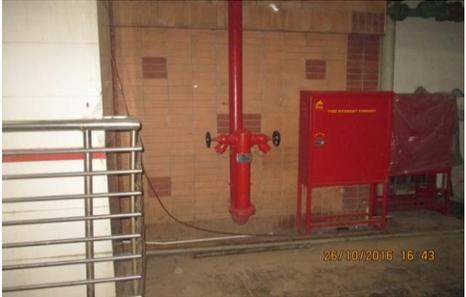
70	The required standpipe system is not installed in accordance with the ACCORD standard.	<p>Install a new standpipe system in accordance with ACCORD standard 5.4 and NFPA 14.</p> <p>A class III system shall be installed in buildings with the highest occupiable floor 10 m (33 ft.) above grade or more.</p> <p>A class I system shall be permitted in buildings protected throughout by an approved automatic sprinkler</p>	Within 6 months	<p>On 03/02/16: Design have been reviewed by Accord. Installation in progress.</p> <p>On 18/04/16: Reviewed design from Accord was available during the follow-up. Piping work was almost completed. All materials were available in the factory premises. Factory committed to complete the installation within the mentioned timeline.</p> <p>On 01/08/2016: Installation is completed.</p> <p>On 26/10/2016: In progress.</p>	31/07/2016		In Progress

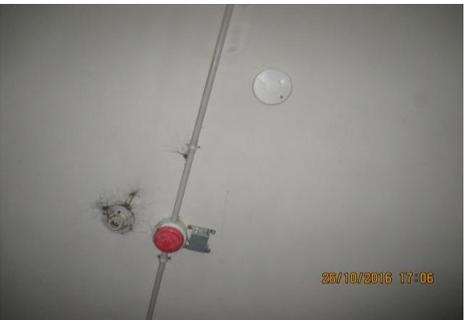
71	The building is equipped with single-station smoke alarms. Smoke alarm activation sounds only a local alarm and does not provide automatic fire alarm	Remove single-station smoke alarms. Provide automatic smoke detection throughout the building, tied into the fire alarm system, in accordance with NFPA 72.	Within 9 months	<p>On 03/02/16: Design has been reviewed by Accord. Work in progress.</p> <p>On 18/04/16: It is an integrated part of fire alarm system.</p> <p>On 01/08/2016: Single station smoke alarm is replaced with smoke detectors but installed smoke detectors were not functional.</p> <p>On 26/10/2016: It is an integrated part of fire alarm system.</p>	30/06/2016		In Progress

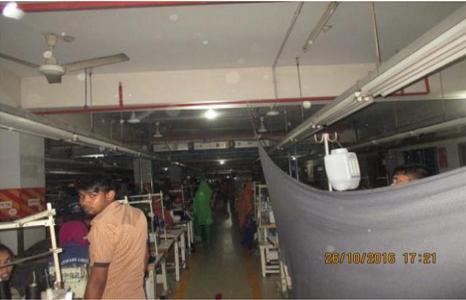
72	Based on the number and location of emergency lights observed, adequate illumination levels are not anticipated	Test the emergency lighting system on each floor and provide additional emergency fixtures to supply adequate illumination along the means of egress. Provide a minimum illumination of 10 lux at the floor level within exit stairs and along exit	Within 3 months	<p>On 03/02/16: Adequate light are not found in the factory floors.</p> <p>On 18/04/16: During the follow-up, adequate illumination along the aisles had not been observed.</p> <p>On 01/08/2016: Corrected.</p> <p>On 26/10/2016: Corrected.</p>	20/05/2016		Corrected

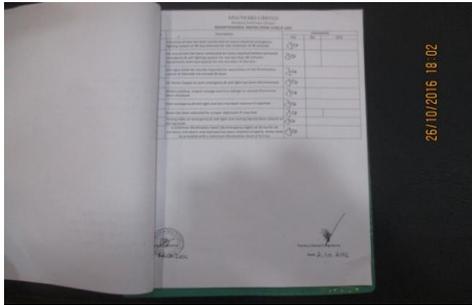
Item No	Accord Observation	Accord Recommendation	Timeline given by Accord	Comments after Physical Inspection	Supposed to complete(D D/MM/YY)	Final Action Plan	Status on the date of Inspection	Pictorial Evidence
73	Inspection, testing and maintenance for the emergency lighting system was not in accordance with The ACCORD standard.	Inspect, test and maintain the emergency lighting system in the accordance with The ACCORD standard. Keep written records on-site.	Within 3 months	On 03/02/16: Need to be according to Accord standard. On 18/04/16: Corrected. Factory is maintaining the checklist as per the standard. (Adequate illumination will be provided along all aisles as committed by factory personnel) On 01/08/2016: Corrected. On 26/10/2016: Corrected.	10/02/2016		Corrected

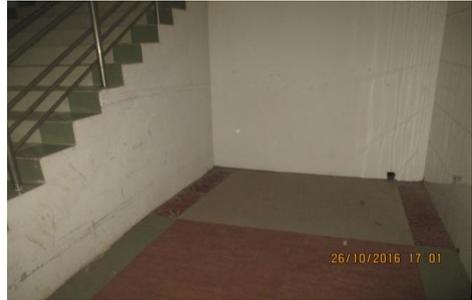
74	NEW FINDING: (1st Followup) Storage was located in exit stair.	Remove all storage from exit stairs and egress paths.	Immediate	On 03/02/16: Storage removed from one site. But still pump found in other exit stair On 18/04/16: Corrected. Pump area has no connection with the staircase now. On 01/08/2016: Corrected. On 26/10/2016: Corrected.	28/02/2016		Corrected

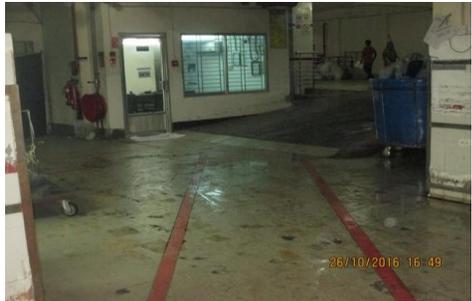
75	New Finding (1st follow up) Storage was located in exit stair	Storage was located in the egress path for the dyeng shed.	Immediate	On 03/02/16: Corrected. On 18/04/16: Corrected. No such storage has been found in the egress path for dyeing shed. On 01/08/2016: Corrected. On 26/10/2016: Corrected.	07/08/2015		Corrected

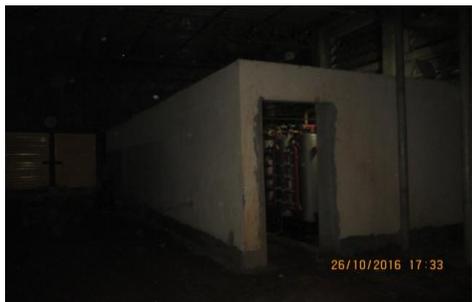
76	NEW FINDING (2nd follow up): Gas storage was located in the dyeing shed.	Remove all gas storage to a minimum distance of 30 ft. within the premise.	Within 3 months	On 03/02/16: New Finding On 18/04/16: Corrected. Based on practical site condition, the gas storage in a safe place now. On 01/08/2016: Corrected. This issue is given corrected as it was given corrected during 3rd Follow-up inspection. On 26/10/2016: Corrected.	18/04/2016		Corrected

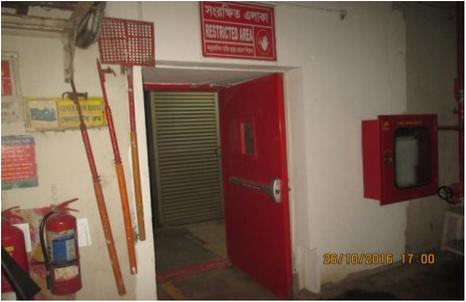
Item No	Accord Observation	Accord Recommendation	Timeline given by Accord	Comments after Physical Inspection	Supposed to complete(D D/MM/YY)	Final Action Plan	Status on the date of Inspection	Pictorial Evidence
77	NEW FINDING (2nd follow up): Generator on the ground floor at the side of the stair of the 7 storey building is not separated by fire-rated construction.	Provide a fire separation construction of minimum 2 hrs and separate from the exit path.	Within 3 months	On 03/02/16: New Finding On 18/04/16: Corrected. Factory is not using this stair as an exit stair. In above floors, they are not keeping access to use the stair. (In future if the factory wants to use it, they need to do the needful) On 01/08/2016: Corrected. Fire door has been provided at the generator room. On 26/10/2016: Corrected.	18/04/2016		Corrected

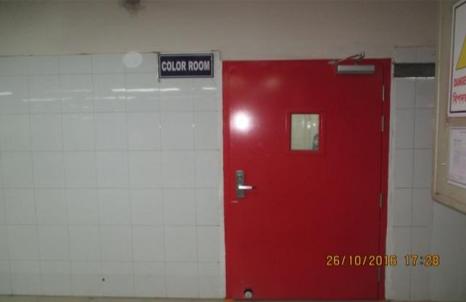
78	NEW FINDING (2nd follow up): Chemical storage on the 6th floor of the 7 storey building is not separated by fire-rated construction.	Provide a fire separation construction of minimum 2 hrs.	Within 3 months	On 03/02/16: New Finding On 18/04/16: Partially corrected. Civil work & fire door installation is in progress. Interfacing required. On 01/08/2016: Corrected. Fire doors are installed & interfaced with FACP. On 26/10/2016: Corrected.	03/05/2016		Corrected

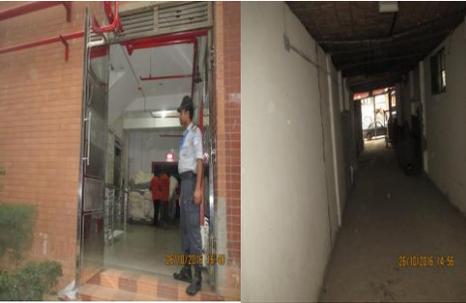
79	New Finding (4th Follow-up): Egress doors with locking features are provided at exit stairs. Egress gates with locking features exit stairs and exit discharge	Remove locking features from all egress doors and gates. If locks are required for security reasons, utilize special door locking features complying with NFPA 101 and ACCORD standard 6.8.2.	Immediate	On 01.08.2016: New Finding Note: 1. During inspection, exit discharge from North Exit Stair was found with Non-Compliant locks. Factory claimed they always keep this door open but factory is required to remove locking features. 2. Locking feature was also present at South Exit Stair Discharge path. On 26/10/2016: Corrected.	08/08/2016		Corrected
