FIRE SAFETY FOLLOW UP INSPECTION

Factory Name	Multifabs Ltd		
Address	Kashimpur, Nayapara, Gazipur		
Inspection Date	04/09/2014		
Date Report Received	01-June/14		
Date of 1st Follow-up	28-July/15	Date of 2nd Follow-up	03-February/16
Date of 3rd Follow-up	18-April/16	Date of 4th Follow-up	01-August/16
Date of 5th Follow-up	26-October/16		
Inspected by	Md. Anayet Hossain.

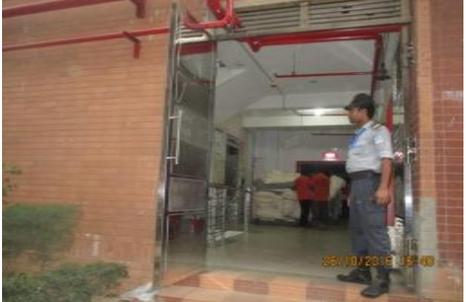
80	New Finding (4th Follow-up): Egress door serving 50 or more occupants but does not swing in the direction of egress travel.	Modify swing direction of egress doors to the direction of egress travel. Doors serving an occupant load of more than 50 shall swing in the direction (out-ward) of egress travel.	Within 1 month	On 01.08.2016: New Finding. On 26/10/2016: Corrected.	01/09/2016		Corrected

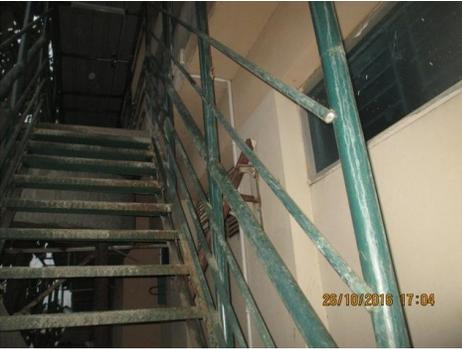
Item No	Accord Observation	Accord Recommendation	Timeline given by Accord	Comments after Physical Inspection	Supposed to complete(D D/MM/YY)	Final Action Plan	Status on the date of Inspection	Pictorial Evidence
81	New Finding (4th Follow-up): The exterior exit stair is not separated from the building.	Exterior exit stairs shall be separated by minimum 2-hr fire-rated construction and The rating of the exterior wall shall extend 3.05 m (10 ft.) beyond the ends of the stair structure. Provide minimum 1.5-hr fire rated doors to separate the exit stairs from work areas and other building spaces on all floor levels. Ensure that the fire doors are self-closing, positive latching and that they are provided with fire exit (panic) hardware where serving production floors. If fire doors are required to be held open for functional reasons, provide automatic-closing devices tied to the	Within 1 month	On 01.08.2016: New Finding. On 26/10/2016: Work in progress.	01/09/2016		In Progress

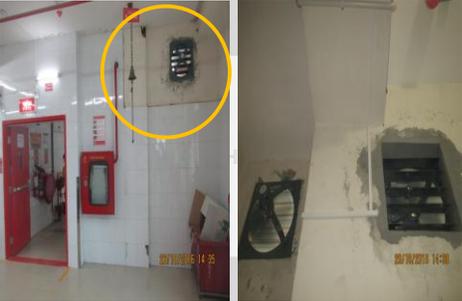
82	New Finding (5th Follow-up): Penetration has been found in Store rooms. Location: Various floors at 10 story building.	Seal all the penetration with fire rated assemblies.	Within 1 month	On 26/10/2016: New Finding.	26-11-2016
