FIRE SAFETY INSPECTION REPORT

MULTIFABS LTD KASHIMPUR, NAYAPARA

Fire Safety Inspection Report Multifabs Ltd

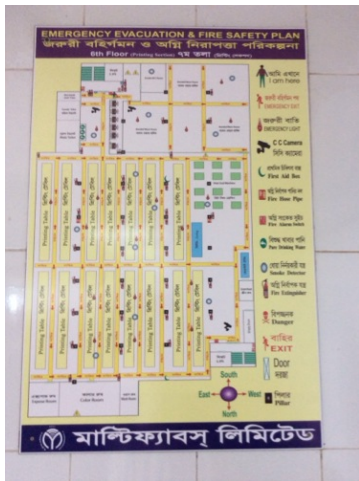
Exemplar emergency plans

Emergency Evacuation Plans Provided?	Yes
Fire Drills Conducted	Yes
Records Maintained	Yes

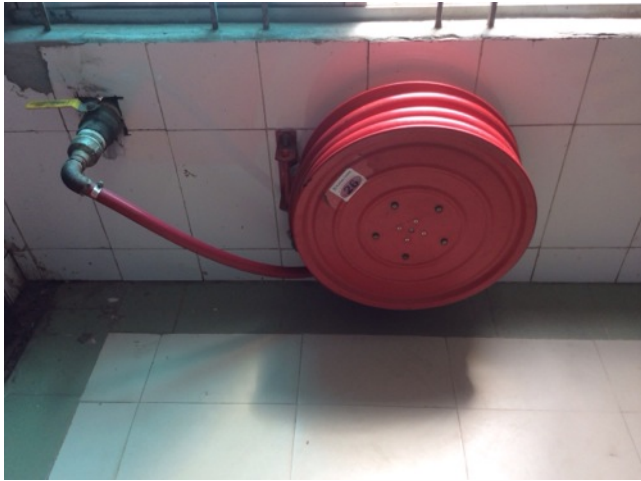
Exemplar hose reel

Two (2) fire hose reels are provided in the building, one at each building exit.

Hose Size(s) Provided 1 in.

Locations At each exit

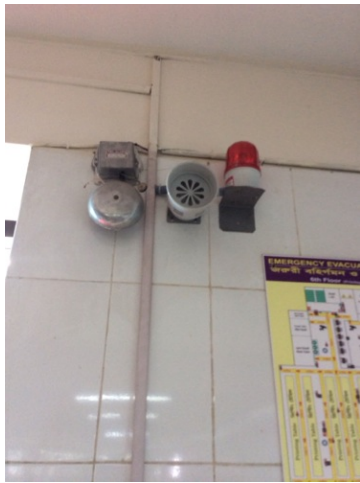
A fire alarm system was provided in the factory building. It consists of manual alarm switches, sirens and beacon units installed near the entrances to each floor. The activation switches on each floor reportedly trigger the fire alarm for the entire building, but are not connected between all buildings in the complex. No functional test was conducted on the system during the inspection. There is no fire alarm panel or system supervision.

Exemplar fire alarm

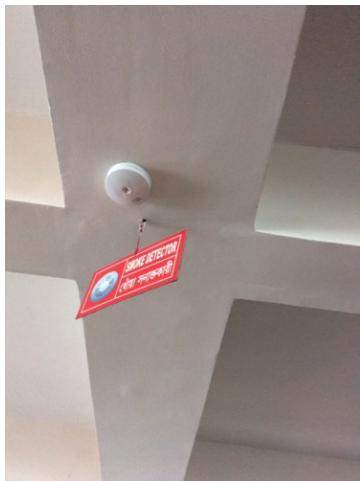
Exemplar smoke alarm

There are no smoke detectors installed in the shed. Heat detectors, interconnected to the fire alarms and an addressable fire panel have been planned.

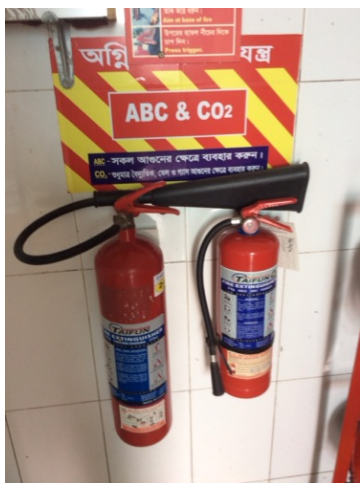
Exemplar fire extinguisher

Types Provided CO2, dry chemical

Adequate Number/Spacing? Yes

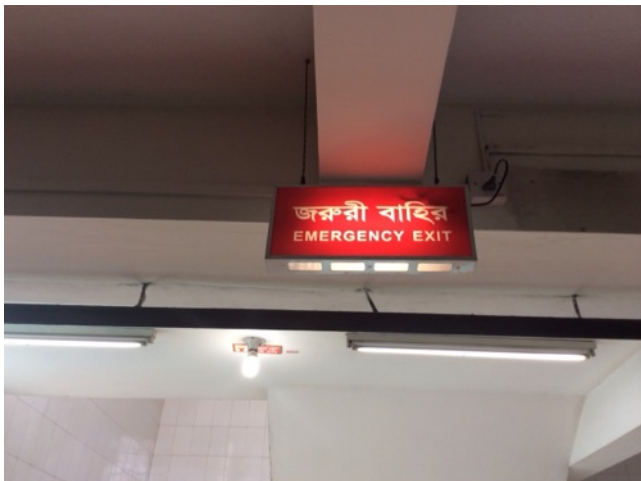
Exemplar emergency exit sign

There were multiple fluorescent lights that are serviced by either an alternate “Instant Power Supply” (IPS) or battery backup located inside and outside the exit enclosure walls as well as throughout the factory floor on each floor. Each floor had a number of illuminated exit signs (a mix of directional and nondirectional) located along the exit access and at exits. The factory reports that these are all serviced by normal electricity as well as by an “Instant Power Supply” (IPS) unit. There were no records or assertions of regular testing or maintenance of the emergency lighting system.

Exits and Exit Access Properly Marked with Exit Signage	Yes
Emergency Power	IPS Battery
Emergency Lighting for Exits & Exit Access	Yes
Regular Inspection, Testing, & Maintenance?	No

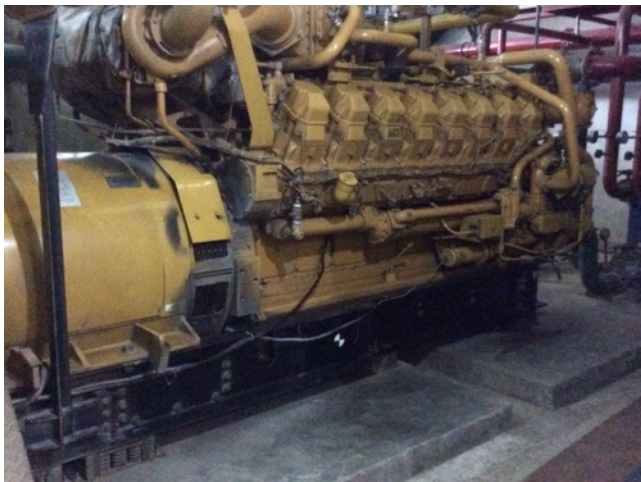
Boilers

Fire Rated Separations Provided? No

The boiler is located on the ground floor adjacent to the Dyeing Shed. It does not have the required fire rated separations. It has an insufficient number of smoke alarms. Sprinklers and heat detectors, interconnected with a centralized fire panel, have been planned.

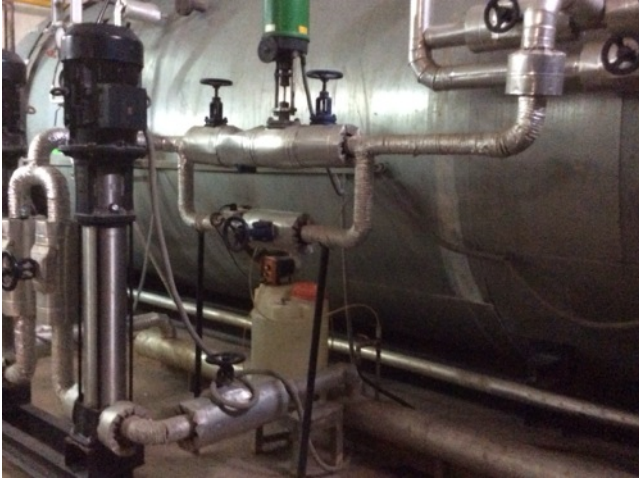
Main boiler

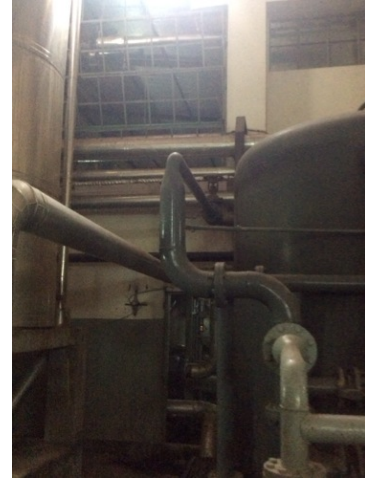
Boiler room unprotected opening

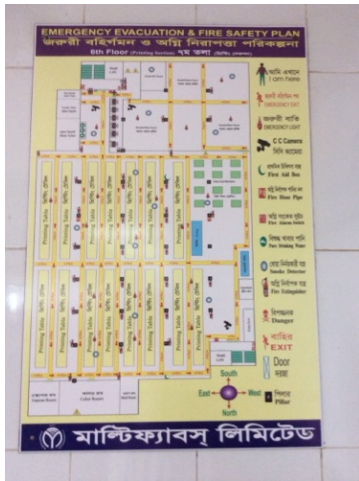
Exemplar emergency plans

Fire Drills Conducted Yes

Records Maintained Yes

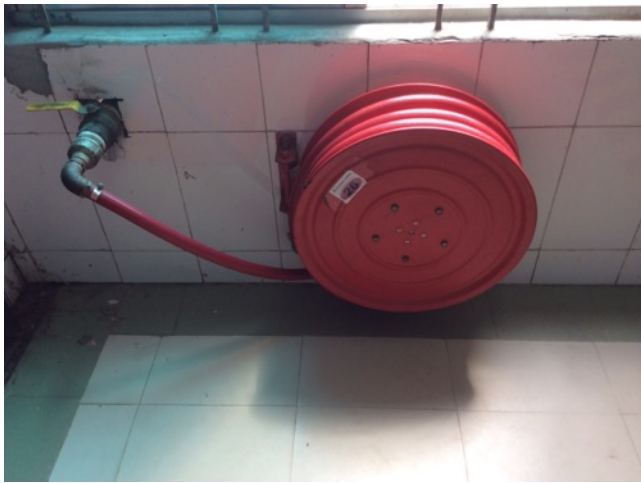
Exemplar hose reel

Hose Size(s) Provided 1 in.

Locations At least 4 locations per floor.

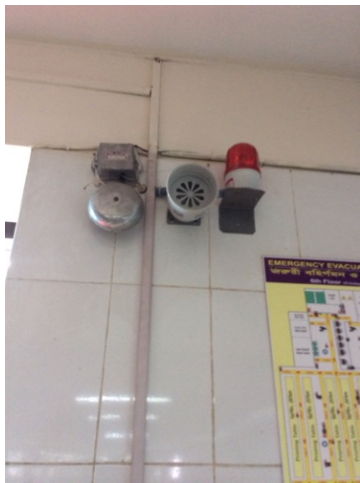
A fire alarm system was provided in the factory building. It consists of manual alarm switches, sirens and beacon units installed near the entrances to each floor. The activation switches on each floor reportedly trigger the fire alarm for the entire building, but are not connected between all buildings in the complex. No functional test was conducted on the system during the inspection. There is no fire alarm panel or system supervision.

Exemplar fire alarm

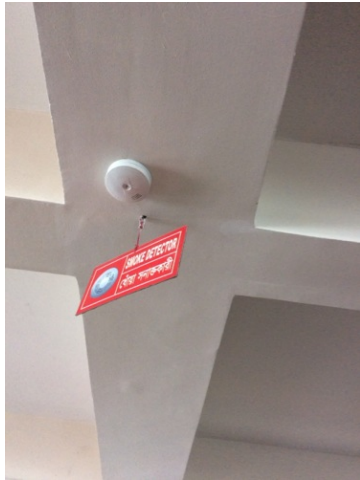
Exemplar smoke alarm

Type of Detectors Single Station Smoke Alarms

**Regular Inspection,
Testing, & Maintenance?** Yes

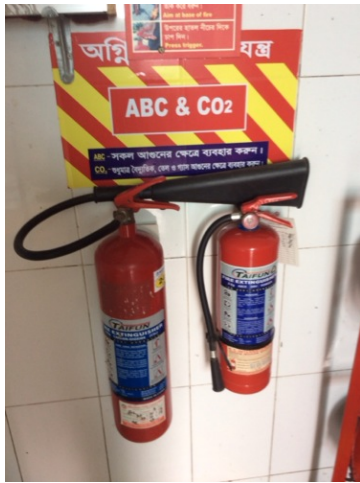
Exemplar fire extinguisher

Types Provided CO2, dry chemical

**Adequate
Number/Spacing?** Yes

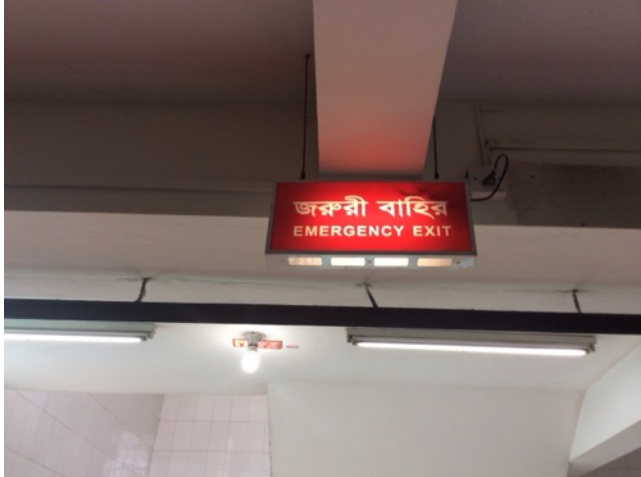
Exemplar emergency exit sign

Emergency Lighting for Exits & Exit Access Yes

Regular Inspection, Testing, & Maintenance? No

Based on the number and location of emergency lights observed, adequate illumination levels are not anticipated along egress routes on the ground floor.

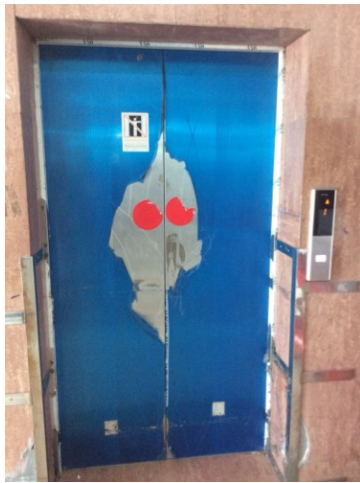
Two elevator are installed on opposite sides of the building. They have neither fire controls nor automatic recall.

Elevator

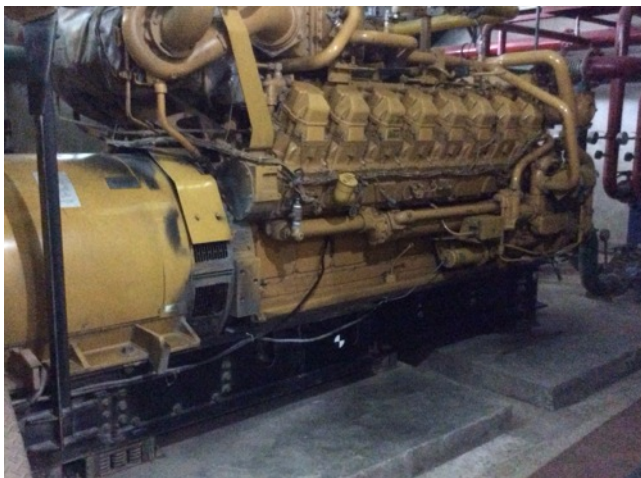
Boilers

Fire Rated Separations Provided? No

The boiler is located on the ground floor adjacent to the Dyeing Shed. It does not have the required fire rated separations. It has an insufficient number of smoke alarms. Sprinklers and heat detectors, interconnected with a centralized fire panel, have been planned.

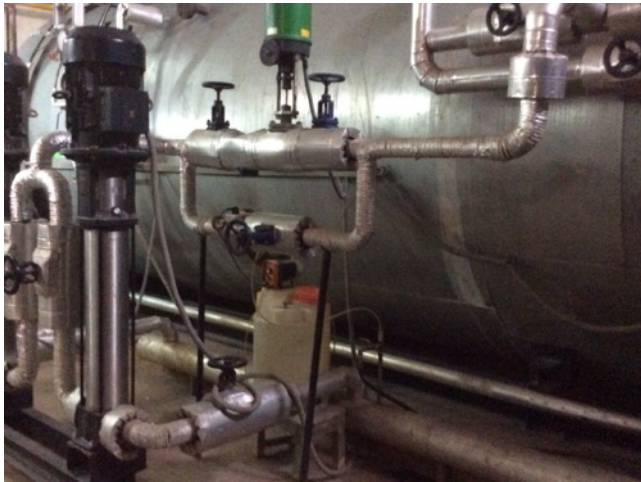
Main boiler

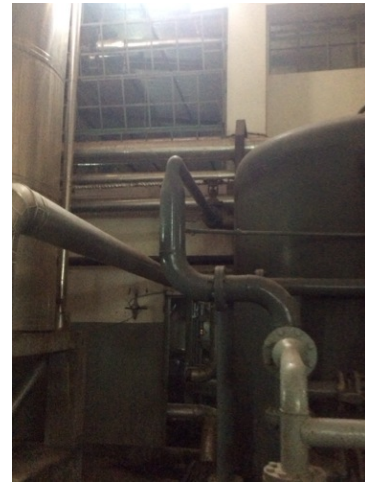
Boiler room unprotected opening

F-3	Fire Rated Construction	The boiler room is not separated by fire-rated construction from the Dyeing Shed.	Separate the boiler room by a minimum 2-hr fire-rated construction. Seal and/or protected all openings to maintain the required fire separations	Within 3 months
-----	-------------------------	---	--	-----------------

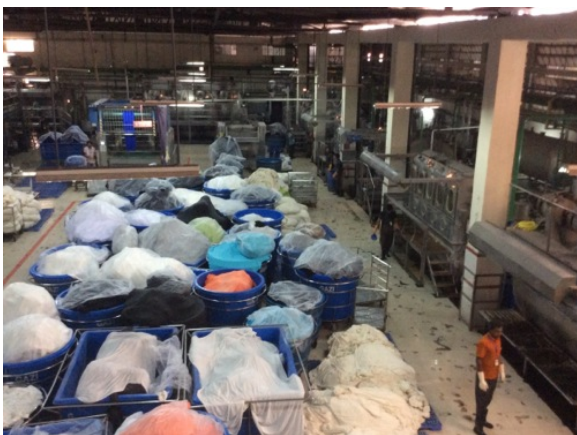
No.	Category	Finding	Recommendation	Remediation Timeframe
F-1	Fire Rated Construction	Process areas throughout the building used for combustible storage are not separated by fire-rated construction.	<p>Provide dedicated storage rooms separated by minimum 1-hr fire-rated construction.</p> <p>Where separate storage rooms are not feasible, provide defined storage areas and limit the storage arrangement as follows:</p> <ul style="list-style-type: none"> - Maximum height of 2.4m and maximum area of 23m² - If sprinkler protected: maximum height of 3.66m and maximum area of 93m² <p>Separate areas of unenclosed combustible storage by a minimum clear distance of 3m.</p>	Within 3 months

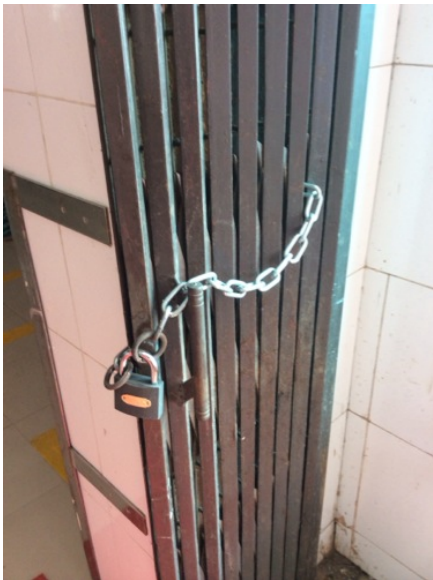
F-2	Egress	Egress doors and gates with locking features are provided throughout the stairwells.	<p>Remove locking features from all egress doors / gates.</p> <p>If locks are required for security reasons, utilize special door locking features complying with NFPA 101.</p>	Immediate
-----	--------	--	---	-----------

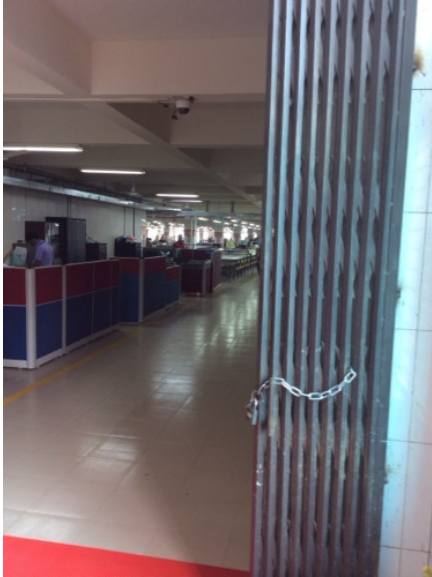
F-3	Egress	Collapsible gates and sliding doors are provided throughout the building.	<p>Replace all gates and sliding doors along the means of egress with side-hinged, swinging egress doors.</p> <p>If locks are required for security reasons, utilize special door locking features complying with NFPA 101.</p>	Within 1 month
-----	--------	---	---	----------------

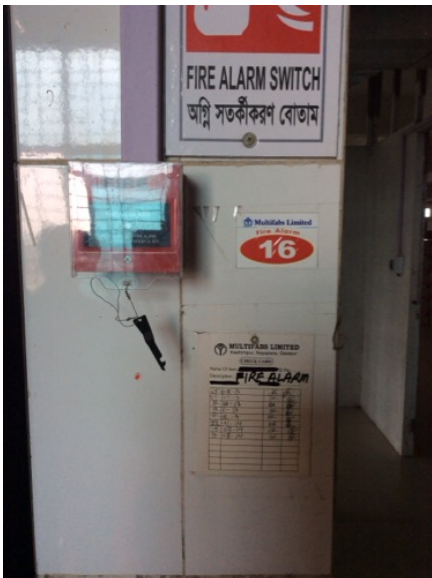
F-4	Fire Protection	The fire alarm system is antiquated, not a listed system, and does not provide alarm and notification features consistent with acceptable standards.	Replace the fire alarm system with a new, listed addressable fire alarm system in accordance with NFPA 72.	Design within 4 months, install within 9 months
-----	-----------------	--	--	---

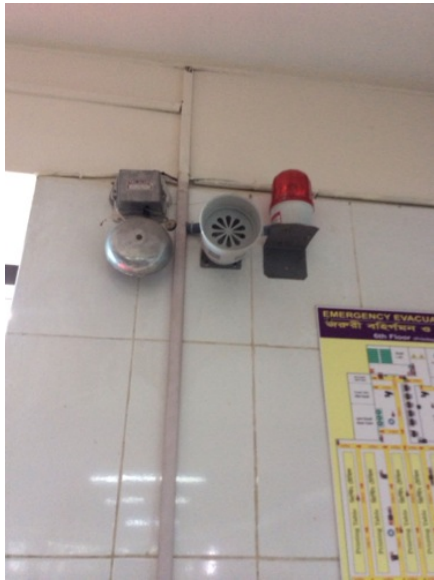
F-5	Fire Protection	Inspection, testing, and maintenance for the fire alarm system was not in accordance with NFPA 72.	Inspect, test and maintain the fire alarm system, and keep written records on-site, in accordance with NFPA 72.	Within 3 months
-----	-----------------	--	---	-----------------

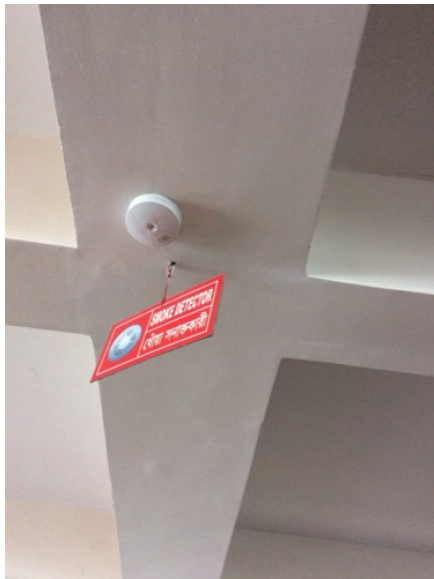
F-6	Fire Protection	The building is not equipped with smoke alarms.	Provide automatic smoke detection throughout the building in accordance with NFPA 72.	Within 6 months
-----	-----------------	---	---	-----------------

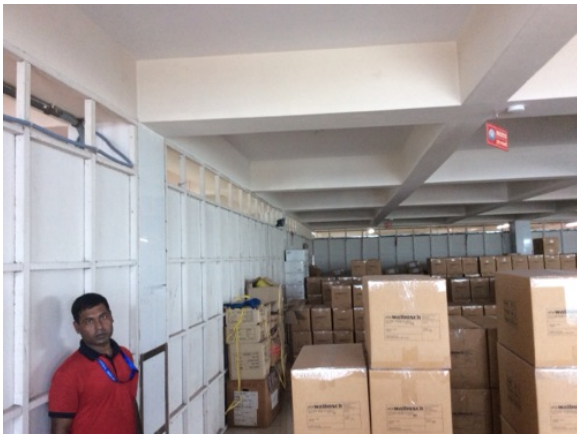
No.	Category	Finding	Recommendation	Remediation Timeframe
F-1	Fire Rated Construction	Storage rooms and process areas throughout the building used for combustible storage are not separated by fire-rated construction.	<p>Provide dedicated storage rooms separated by minimum 1-hr fire-rated construction.</p> <p>Where separate storage rooms are not feasible, provide defined storage areas and limit the storage arrangement as follows:</p> <ul style="list-style-type: none"> - Maximum height of 2.4m and maximum area of 23m² - If sprinkler protected: maximum height of 3.66m and maximum area of 93m² <p>Separate areas of unenclosed combustible storage by a minimum clear distance of 3m.</p>	Within 3 months

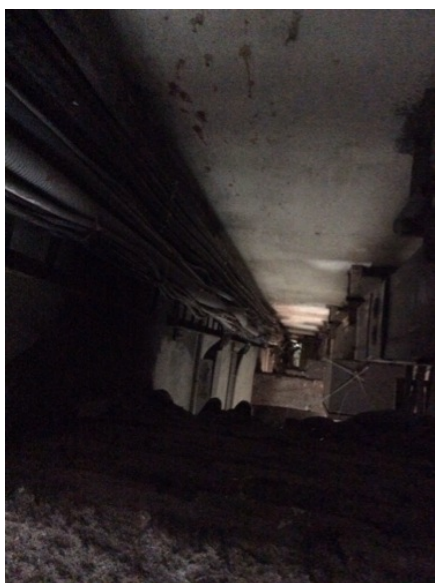
F-4	Fire Rated Construction	Unsealed penetrations and openings are located in the fire-rated floor/ceiling assemblies, specifically the electrical shaft, which connects all floors.	Provide a minimum 2-hr fire-rated shaft to separate the utility risers from each floor level. Seal all penetrations and openings in floor/ceiling assemblies to maintain the fire separation.	Within 3 months
-----	-------------------------	--	--	-----------------

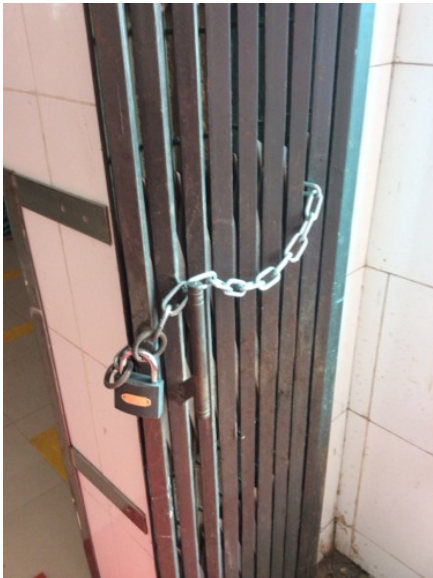
F-5	Egress	The exit capacity of 493 is not adequate for the occupant loads on floors 2, 3, and 4 (650, 710, and 830, respectively).	Immediately reduce occupant load to not more than available exit capacity. If possible, provide additional exits in the future to provide additional exit capacity.	Immediate
F-6	Egress	Egress doors and gates with locking features are provided throughout the stairwells.	Remove locking features from all egress doors / gates. If locks are required for security reasons, utilize special door locking features complying with NFPA 101.	Immediate

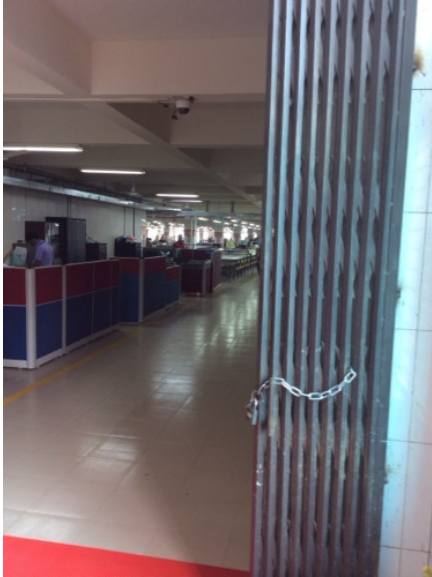
F-7	Egress	Collapsible gates and sliding doors are provided throughout the building.	Replace all gates and sliding doors along the means of egress with side-hinged, swinging egress doors. If locks are required for security reasons, utilize special door locking features complying with NFPA 101.	Within 1 month
-----	--------	---	--	----------------

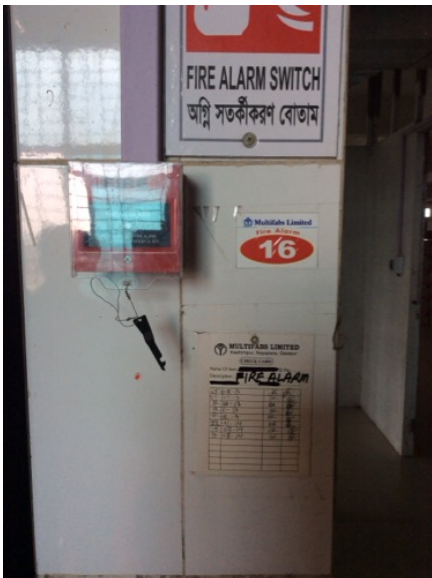
F-8	Fire Protection	The fire alarm system is antiquated, not a listed system, and does not provide alarm and notification features consistent with acceptable standards.	Replace the fire alarm system with a new, listed addressable fire alarm system in accordance with NFPA 72.	Design within 4 months, install within 9 months
-----	-----------------	--	--	---

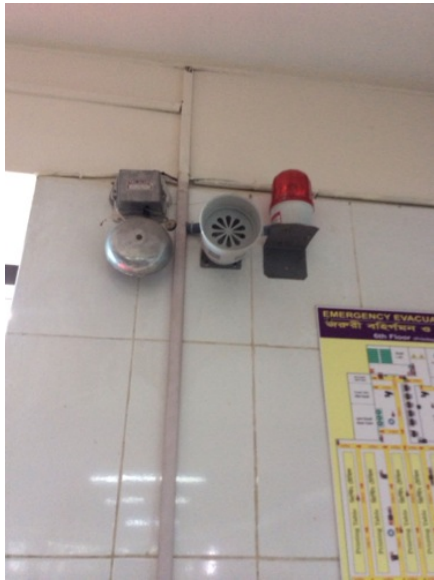
F-9	Fire Protection	Inspection, testing, and maintenance for the fire alarm system it was not in accordance with NFPA 72.	Inspect, test and maintain the fire alarm system, and keep written records on-site, in accordance with NFPA 72.	Within 3 months
-----	-----------------	---	---	-----------------

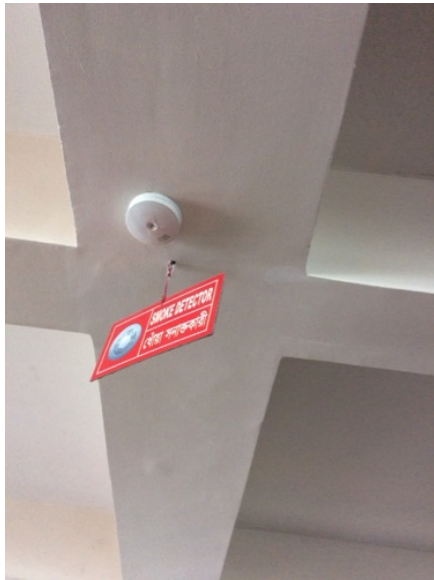
F-10	Fire Protection	The high-rise building has an occupied floor greater than 23m (75 ft) and is not provided with automatic sprinkler protection. The large occupant loads, heavy fuel loading, and anticipated extended egress times warrant sprinkler protection.	Provide automatic sprinkler protection throughout the building in accordance with NFPA 13.	Within 3 months
F-11	Fire Protection	The building is equipped with single-station smoke alarms. Smoke alarm activation sounds only a local alarm and does not provide automatic fire alarm notification of occupants.	Remove single-station smoke alarms. Provide automatic smoke detection throughout the building in accordance with NFPA 72.	Within 6 months

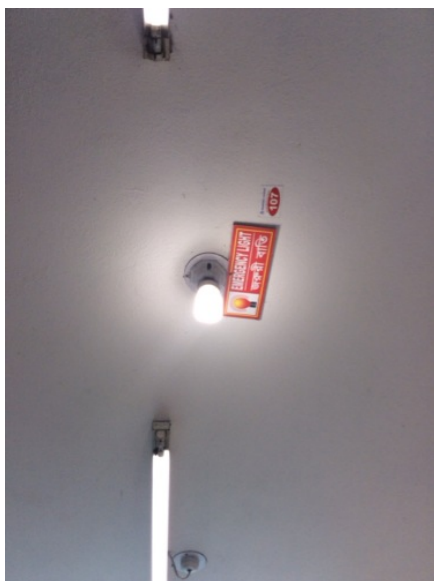
F-12 Egress Lighting

Test the emergency lighting system on each floor and provide additional emergency fixtures to provide adequate illumination along the means of egress. Provide a minimum illumination of 10 lux at the floor level within exit stairs and exit discharge paths and minimum 2.5 lux along exit access aisles.
