FIRE SAFETY FOLLOW UP INSPECTION

Factory Name	Multifabs Ltd		
Address	Kashimpur, Nayapara, Gazipur		
Inspection Date	04/09/2014		
Date Report Received	01-June/14		
Date of 1st Follow-up	28-July/15	Date of 2nd Follow-up	03-February/16
Date of 3rd Follow-up	18-April/16	Date of 4th Follow-up	01-August/16
Date of 5th Follow-up	26-October/16		
Inspected by	Md. Anayet Hossain.

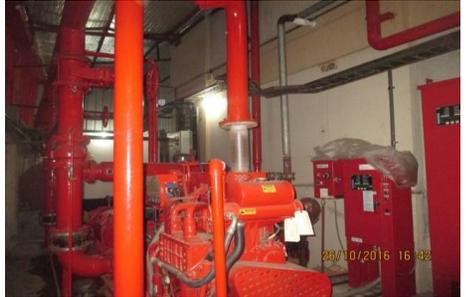
11	The fire pump room is not provided with adequate fire rated separation on the ground floor.	Provide fire pump room with 2 hr. rated fire separation when not sprinklered and 1 hr. rated fire separation when provided with automatic sprinklers, in accordance with NFPA 20.	Within 3 months	On 03/02/16: Not yet corrected. The factory will correct the issue after hydrant installation. On 18/04/16: The existing system will be shifted to another place with the new fire pump. New fire pump is already on site. That will be installed & proper fire separation shall have to be maintained from other occupancies. On 01/08/2016: New fire pump system is installed but installed fire pump room has opening with exit stair of 7-storied building due to the non-rated ceiling. On 26/10/2016: Completed. Required fire separation has been provided.	30/06/2016		Corrected

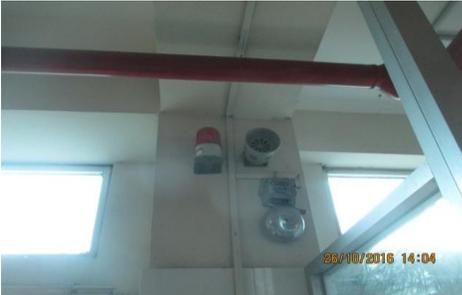
31	Visible notification was not provided for the building in accordance with NFPA 72.	Provide visible notification for the building in accordance with NFPA 72.	Within 3 months	On 03/02/16: It is an integrated part of fire alarm system. On 18/04/16: It is an integrated part of fire alarm system. On 01/08/2016: It is an integrated part of Fire Alarm & Detection System. On 26/10/2016: It is an integrated part of fire alarm system.	30/06/2016		In Progress

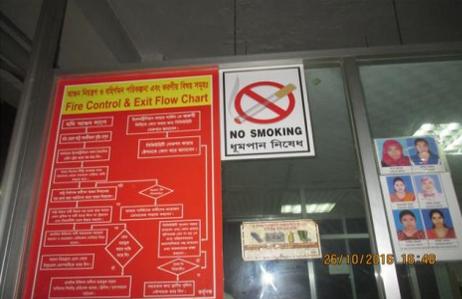
44	The required no smoking signs are not present in the factory.	Smoking is prohibited in any garment factory building or separate storage building. Signs shall be posted in Bengali and English at all building entrances. If the factory creates a designated smoking area outside the building, information of these areas will be posted on the signs.	Within 1 month	On 03/02/16: Corrected. On 18/04/16: Corrected. Provided. On 01/08/2016: Corrected. On 26/10/2016: Corrected.	01/08/2014		Corrected

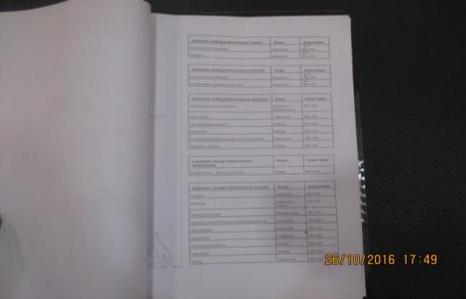
66	Inspection, testing and maintenance of the standpipe system is not in accordance with NFPA 14.	Inspect, test and maintain the standpipe system and keep written records on-site, in accordance with NFPA 14.	Within 3 months	On 03/02/16: It is an integrated part of fire hydrant system On 18/04/16: It is an integrated part of fire fighting system. On 01/08/2016: Corrected. On 26/10/2016: Corrected.	30/06/2016		Corrected

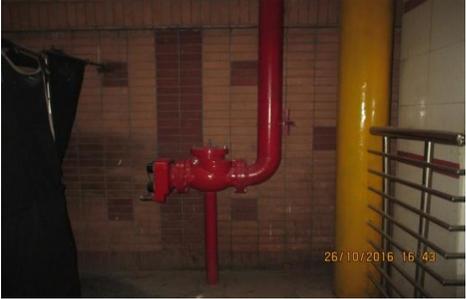
67	Fire department connection is not provided.	Provide fire department connection in accordance with ACCORD standard 5.5.4.	Within 3 months	On 03/02/16: It is an integrated part of fire hydrant system On 18/04/16: It is an integrated part of fire fighting system. On 01/08/2016: It is an integrated part of Fire Fighting System. On 26/10/2016: Corrected.	30/06/2016		Corrected
